ADDENDUM No. 1

**TOWN HALL AND FIRE DEPARTMENT DEMOLITION PROJECT
TOWN of CANTON, NC
Addendum Date: May 13, 2026**

3. The following hazardous material investigation reports by BLE dated May 13, 2026 are attached:
 - a. 21 Adams Street
 - i. Asbestos Containing Materials Survey

- ii. Lead-Based Paint Assessment
 - b. 58 Park Street
 - i. Asbestos Containing Materials Survey
 - ii. Lead-Based Paint Assessment

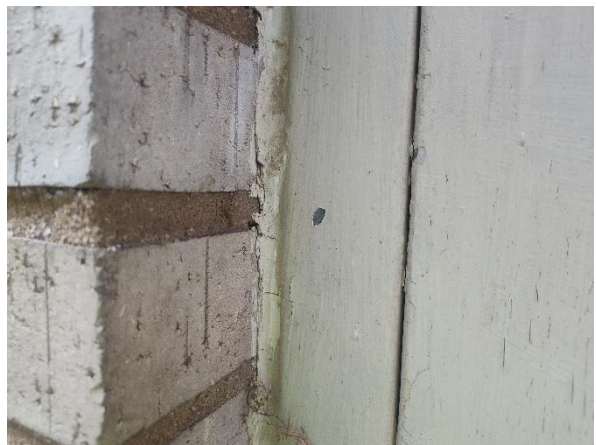
Photo 6: View of the asbestos containing beige caulk on the exterior door frames.

The contractor shall include the abatement and proper disposal of all identified hazardous materials in the above reports in accordance with OSHA requirements in their bid. Hazardous material abatement must be completed prior to commencement of demolition activities.

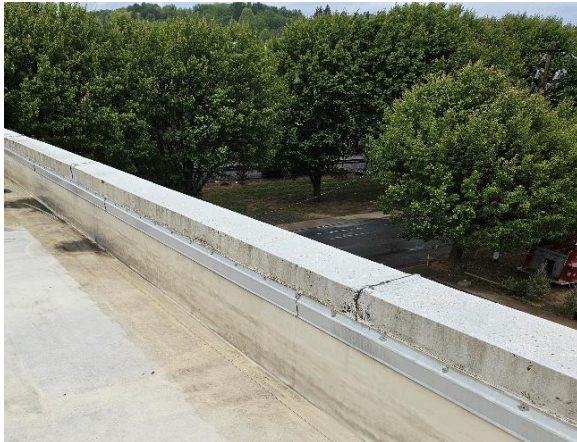
Photo 7: View of asbestos containing white/black tar on the roof parapet wall seams.

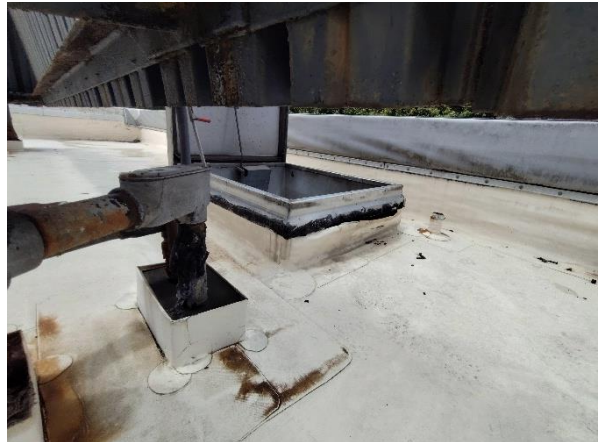
Photo 8: View of the asbestos containing black tar on the metal wall base on the roof.

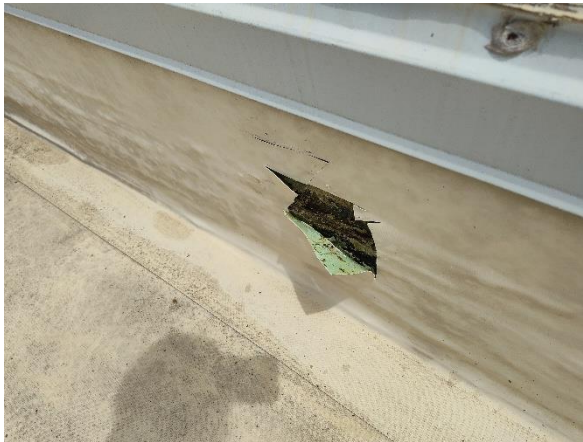
Photo 9: View of the asbestos containing black tar paper on the roof parapet walls.

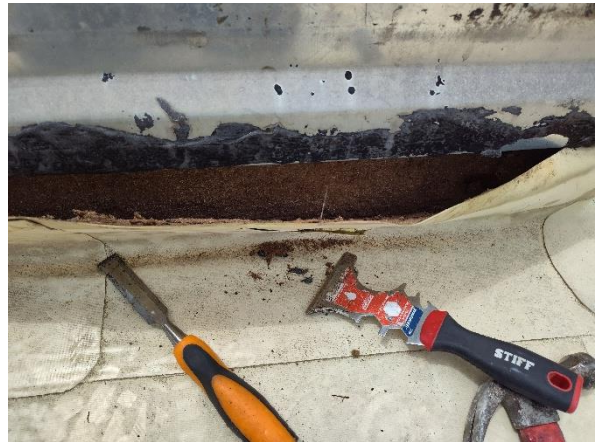
Photo 10: View of the asbestos containing black tar on the base of the HVAC unit and roof hatch.

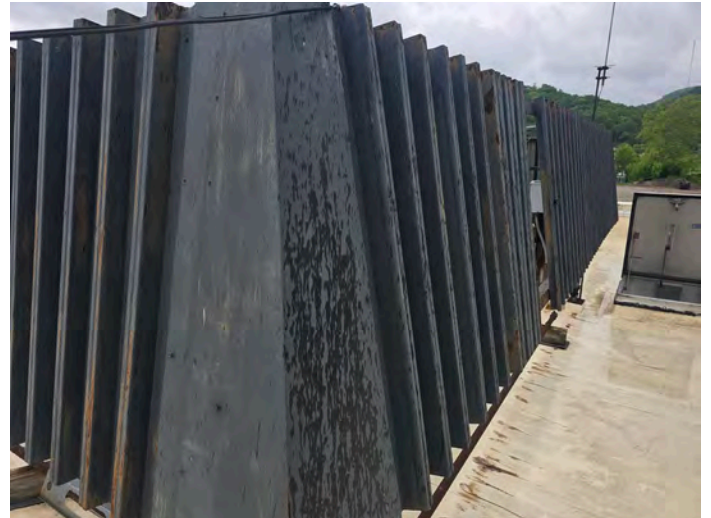
Photo 2 – Green metal wind barrier on the roof – LBP

LBP should not be sanded, torched, grinded on, or disturbed in a manner that will create a dust hazard. Similar precautions should be used on substrates with detectable levels of lead. *XRF LBP Data Tables* are included in Appendix I of this report and identifies materials coated with LBP. XRF results indicate the surfaces presented below are considered LBP:

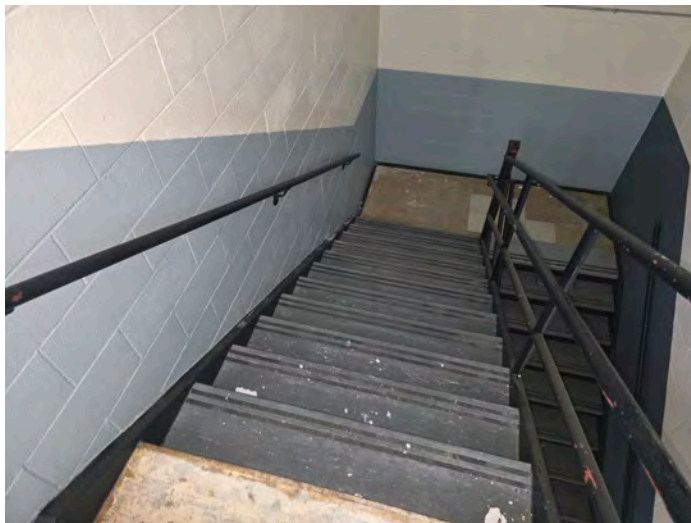
Photo 3 – Black metal handrails in both stairways – LBP

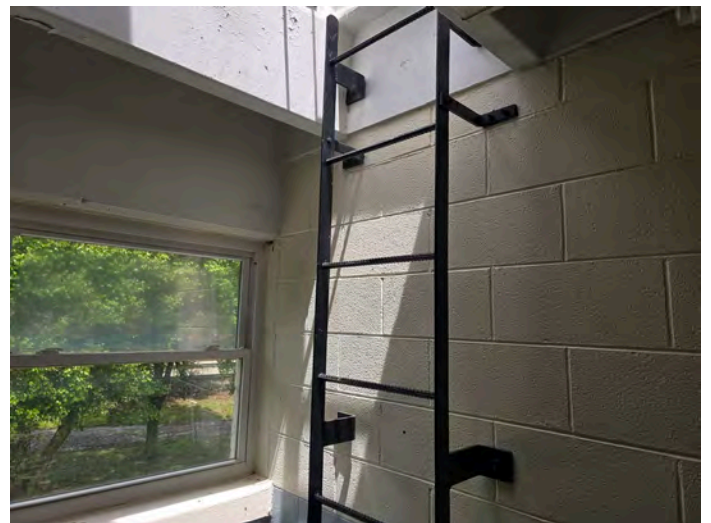
Photo 6 – Black metal roof access ladder in one of the stairways - LBP

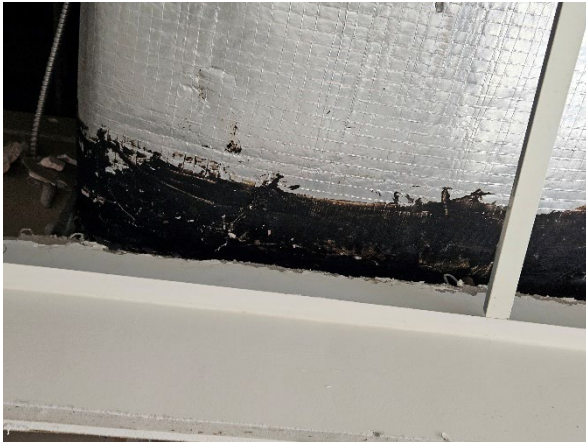
Photo 7: View of the asbestos containing black mastic on the HVAC ductwork in the ceiling.

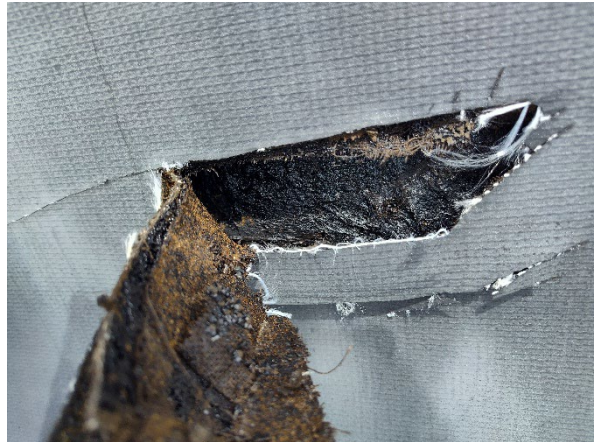
Photo 8: View of the asbestos containing black/brown flashing on the roof parapet walls.

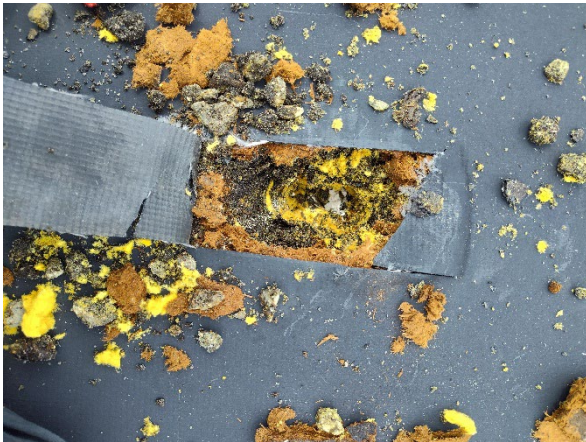
Photo 9: View of the black roofing, brown insulation, yellow insulation, and asbestos containing black/brown flashing on the roof.

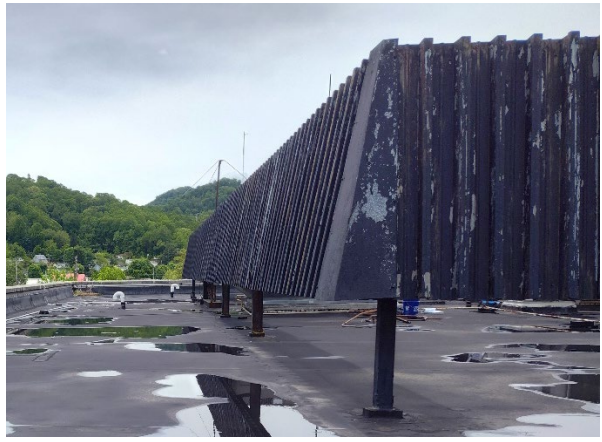
Photo 10: View of the asbestos containing black tar on the base of the metal wall on the roof.

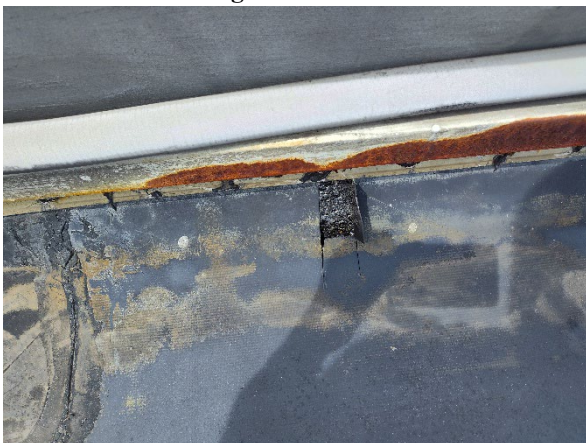
Photo 11: View of the asbestos containing black flashing on the base of the roof HVAC units and roof hatch.

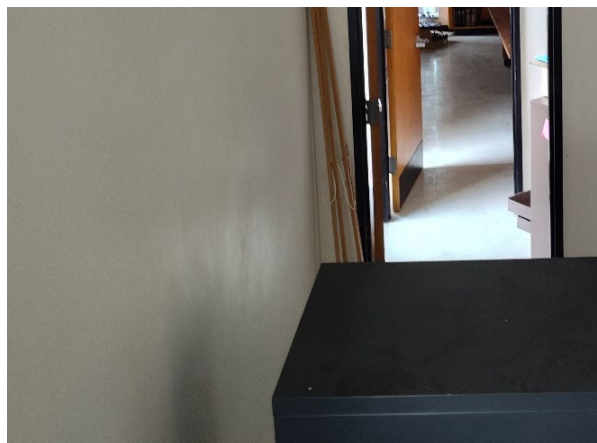
Photo 12: View of the asbestos containing off-white floor tile and underlying black mastic in the central portion and western hallways of the second floor.

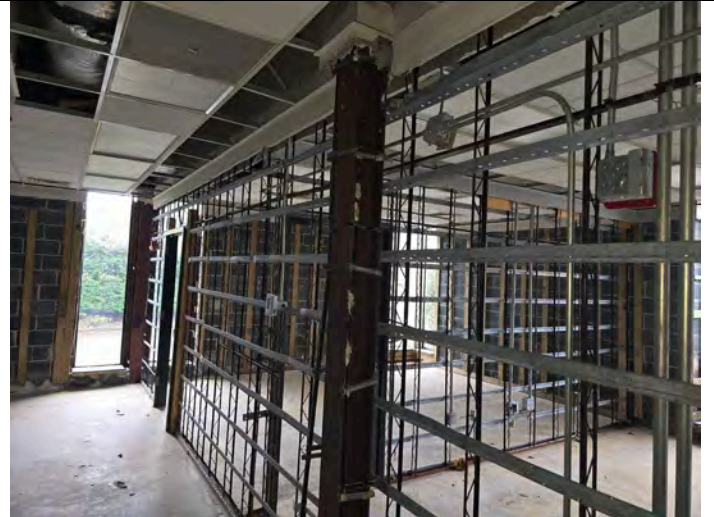
Photo 2 – Red metal I-beams throughout the 1st & 2nd floor - LBP

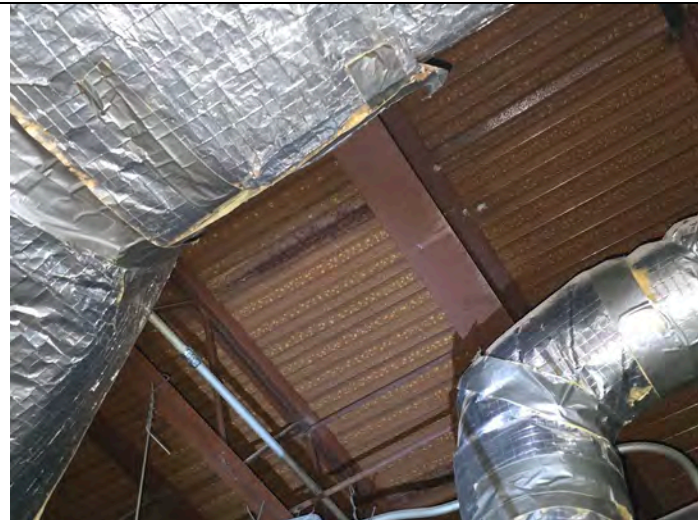
Photo 3 – Red metal I-beams throughout the 1st & 2nd floor - LBP

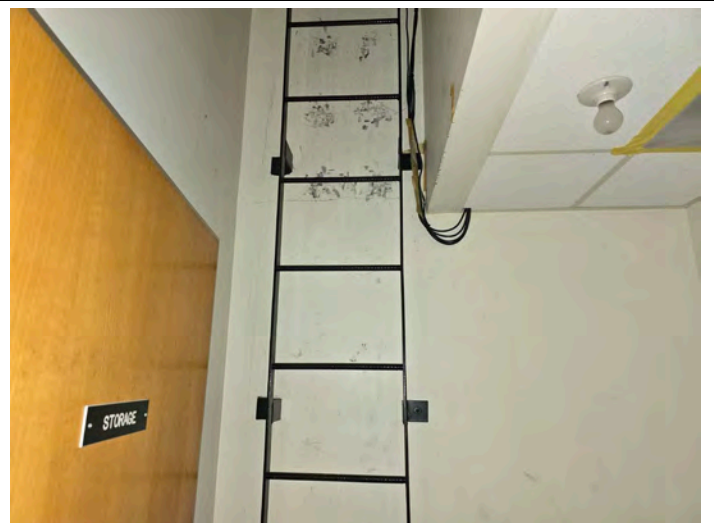
Photo 6 – Black metal roof access ladder near the 2nd floor bathrooms - LBP
