### **Rec Park – Playground**

## MEMORANDUM

**RE:** Canton Playground Repair Recommendations

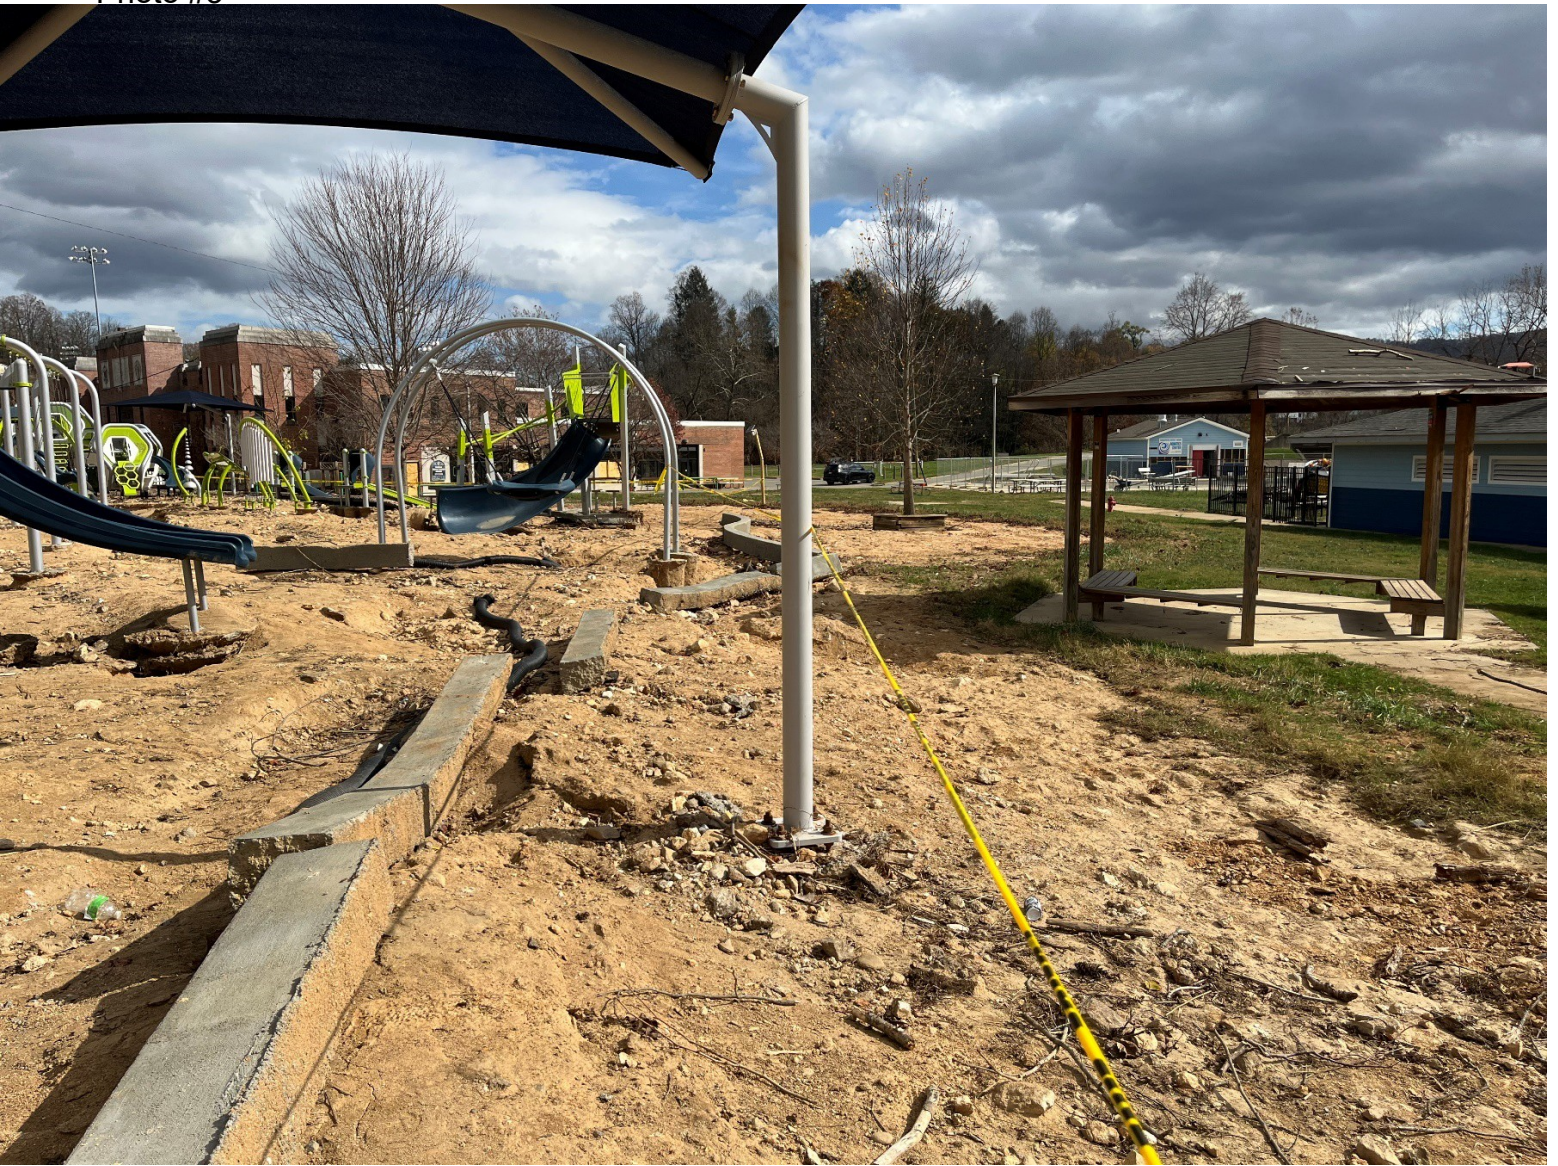
Photo #3

### **2. South Shelter (237637)-refer to photo #3**

- Unbolt, store, regrade area, replace original footing and anchor bolts per specification
- This equipment will be removed and reinstalled, no damage to shelter or shelter base
- Disinfect equipment

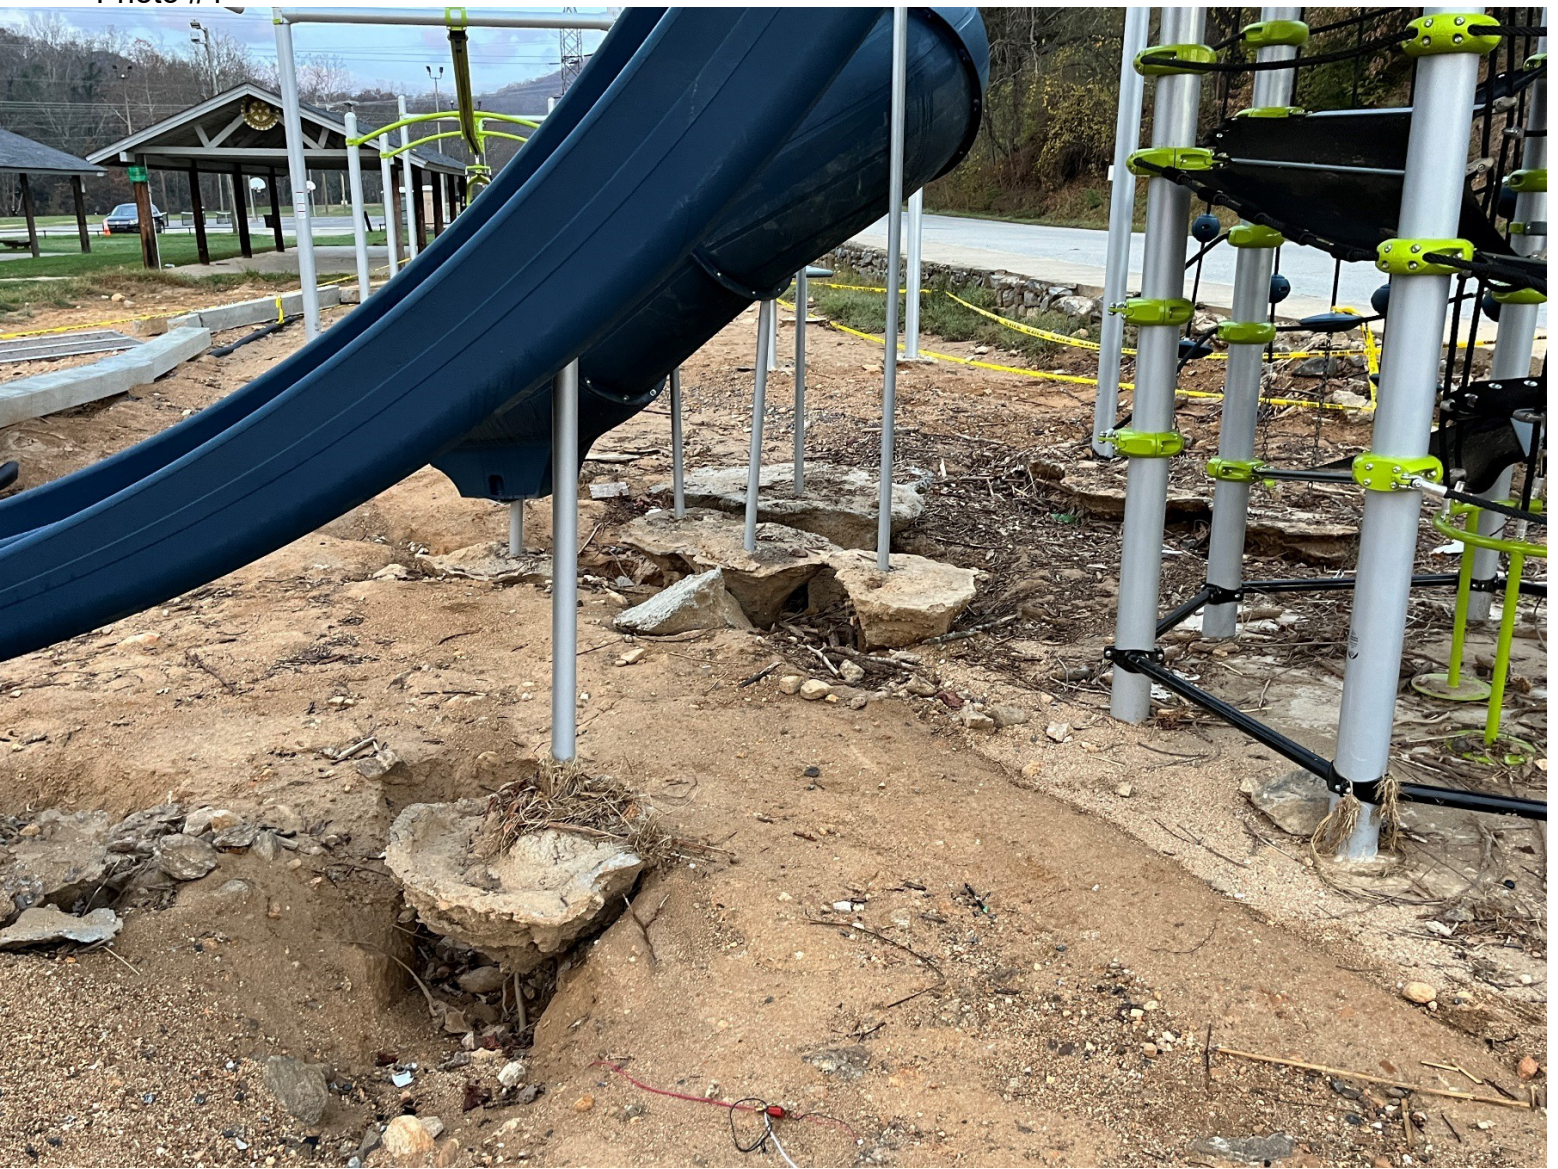
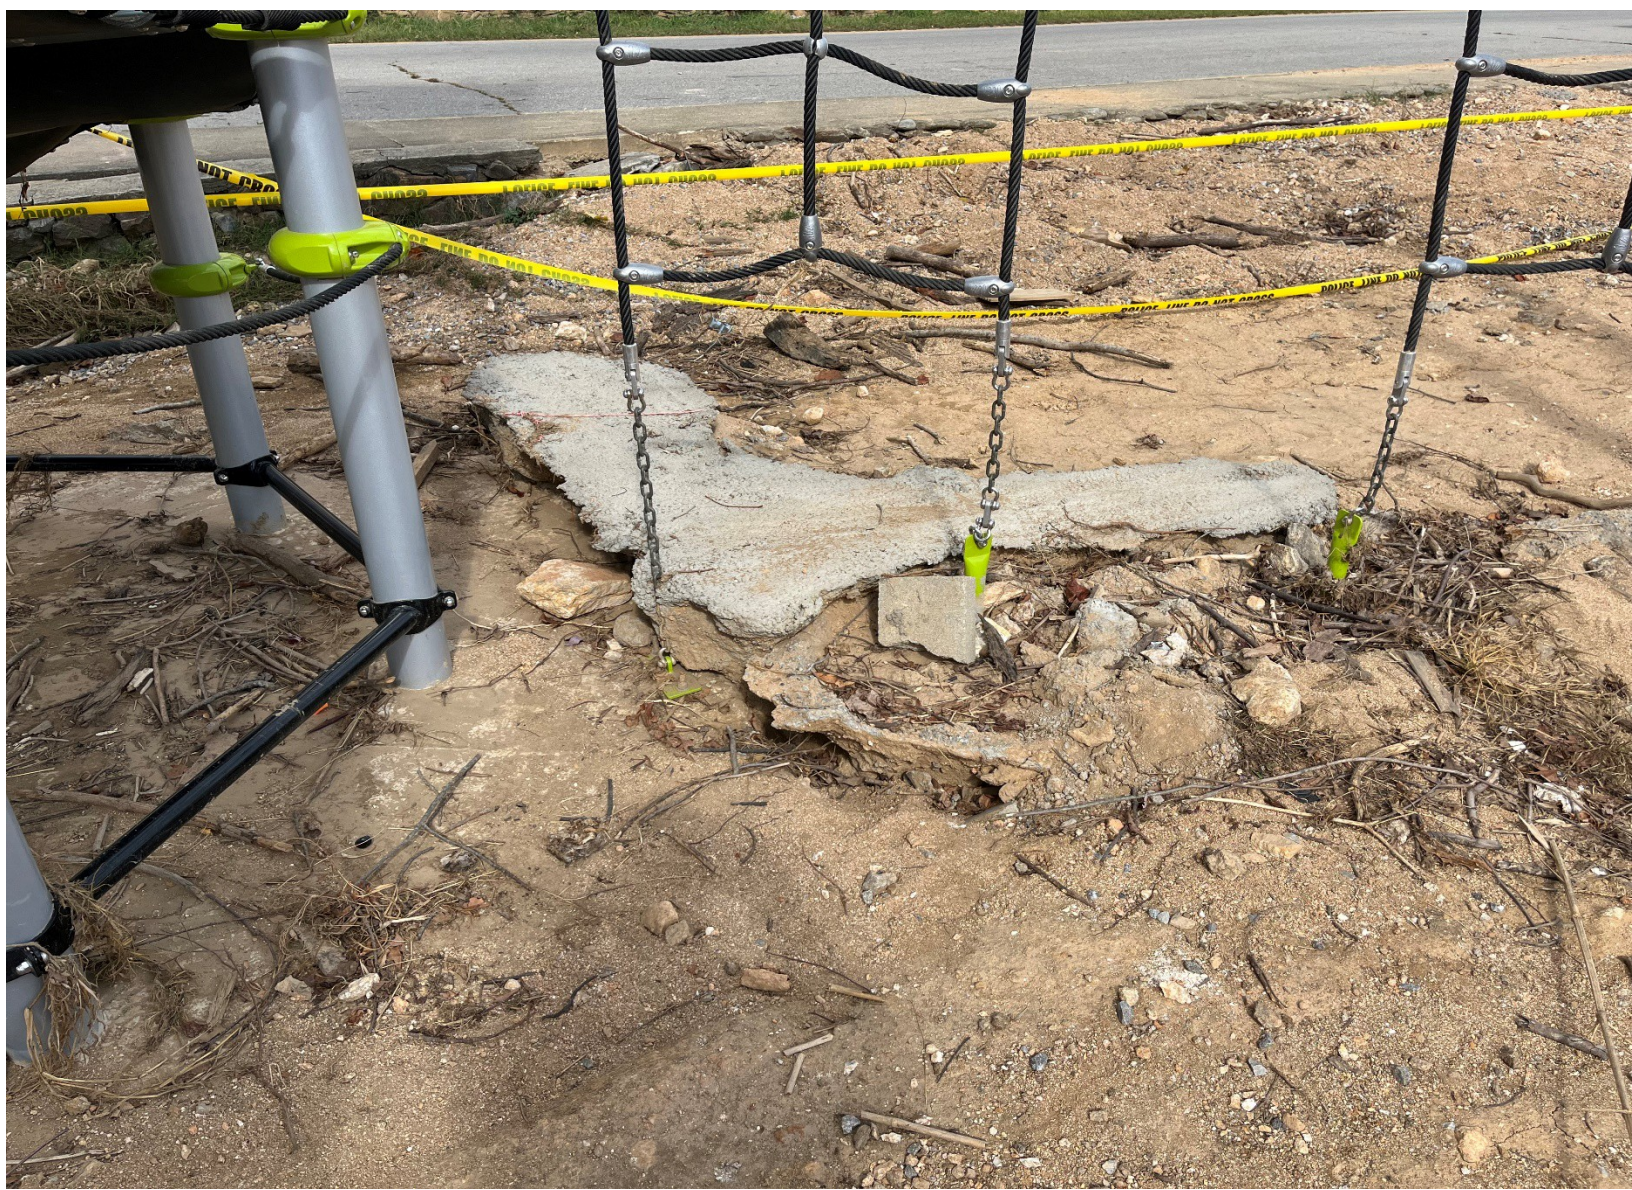
### **3. Super Netplex Tower (254626)-refer to photos #4 and #7**

- Main tower and foundation appear to be undamaged and will remain in place.
  - Disinfect equipment
- Slides and associated support posts have been damaged, and will be demolished and replaced
- Rope climbs and footings have been damaged beyond repair, and should be demolished and replaced
- Regrade entire area outside of the main tower footing, reinstall footings for slide and rope climbs per original specification
- Clean and sanitize main tower
- Backfill area above main tower footing with gravel or screenings to establish proper grade to receive rubber surface treatment

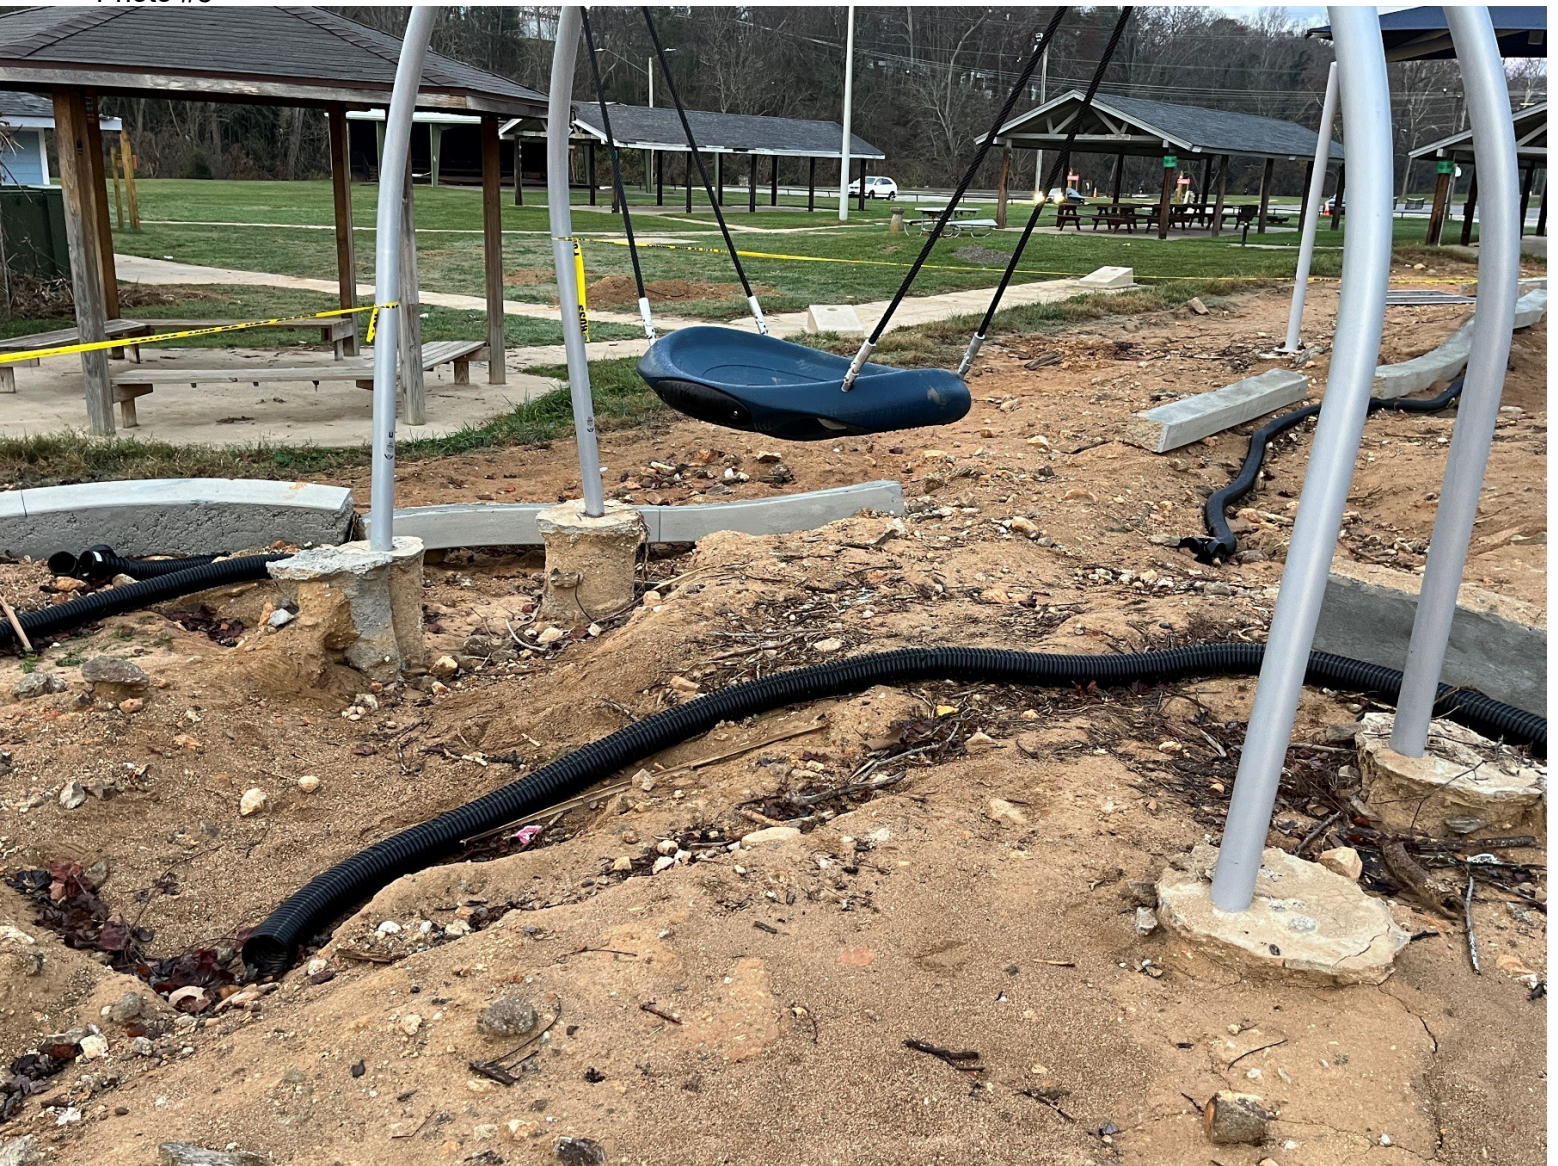
Photo #8

### **4. Oodle Swing (173592)-refer to photo #8**

- Signs of multiple debris impacts
- Bent support leg
- Demolish and replace
- Entire area needs regraded prior to placement of new footing and installation of new equipment

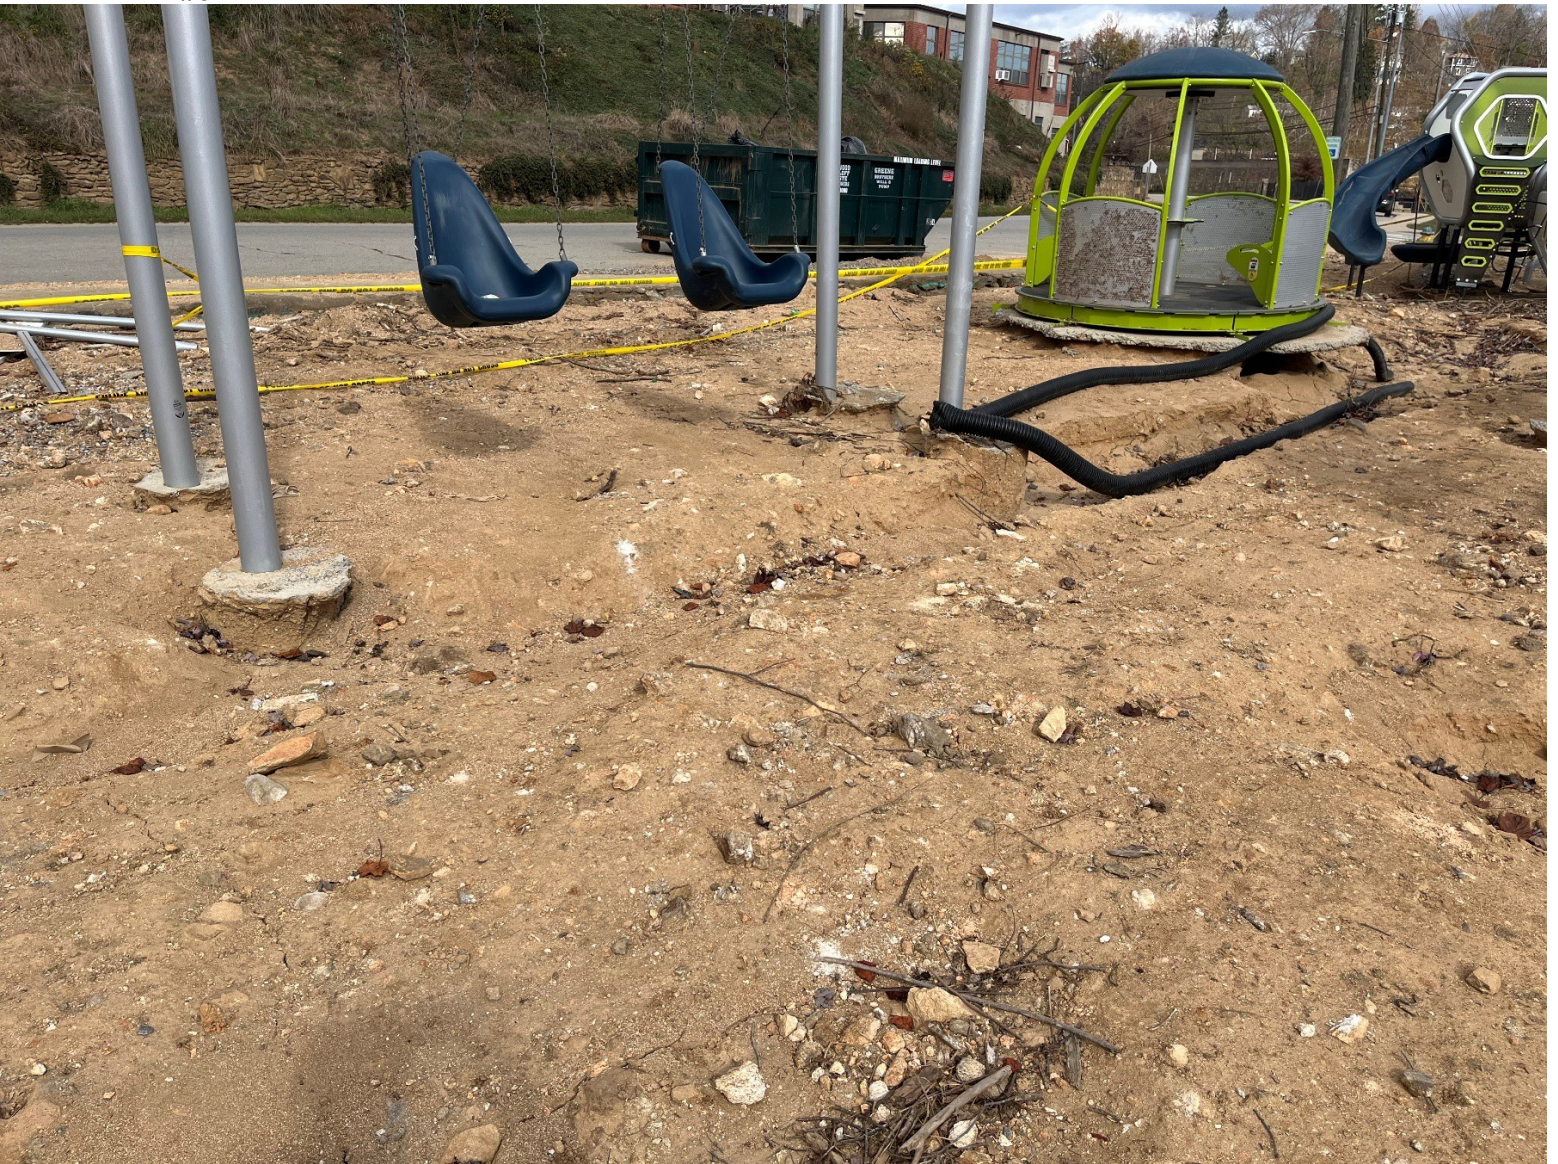
Photo #9

### **5. Double Arch Swing (174018. 221293. 221292)- refer to photo #9**

- This equipment appears to be undamaged, other than some scour around the top few inches of the individual post footings
- Bring to grade (top of existing footing) with 3'x3' concrete pad to achieve footing confinement to required depth around posts
- Remaining area brought to grade with #67 stone or screenings to confine post footings
- Disinfect equipment

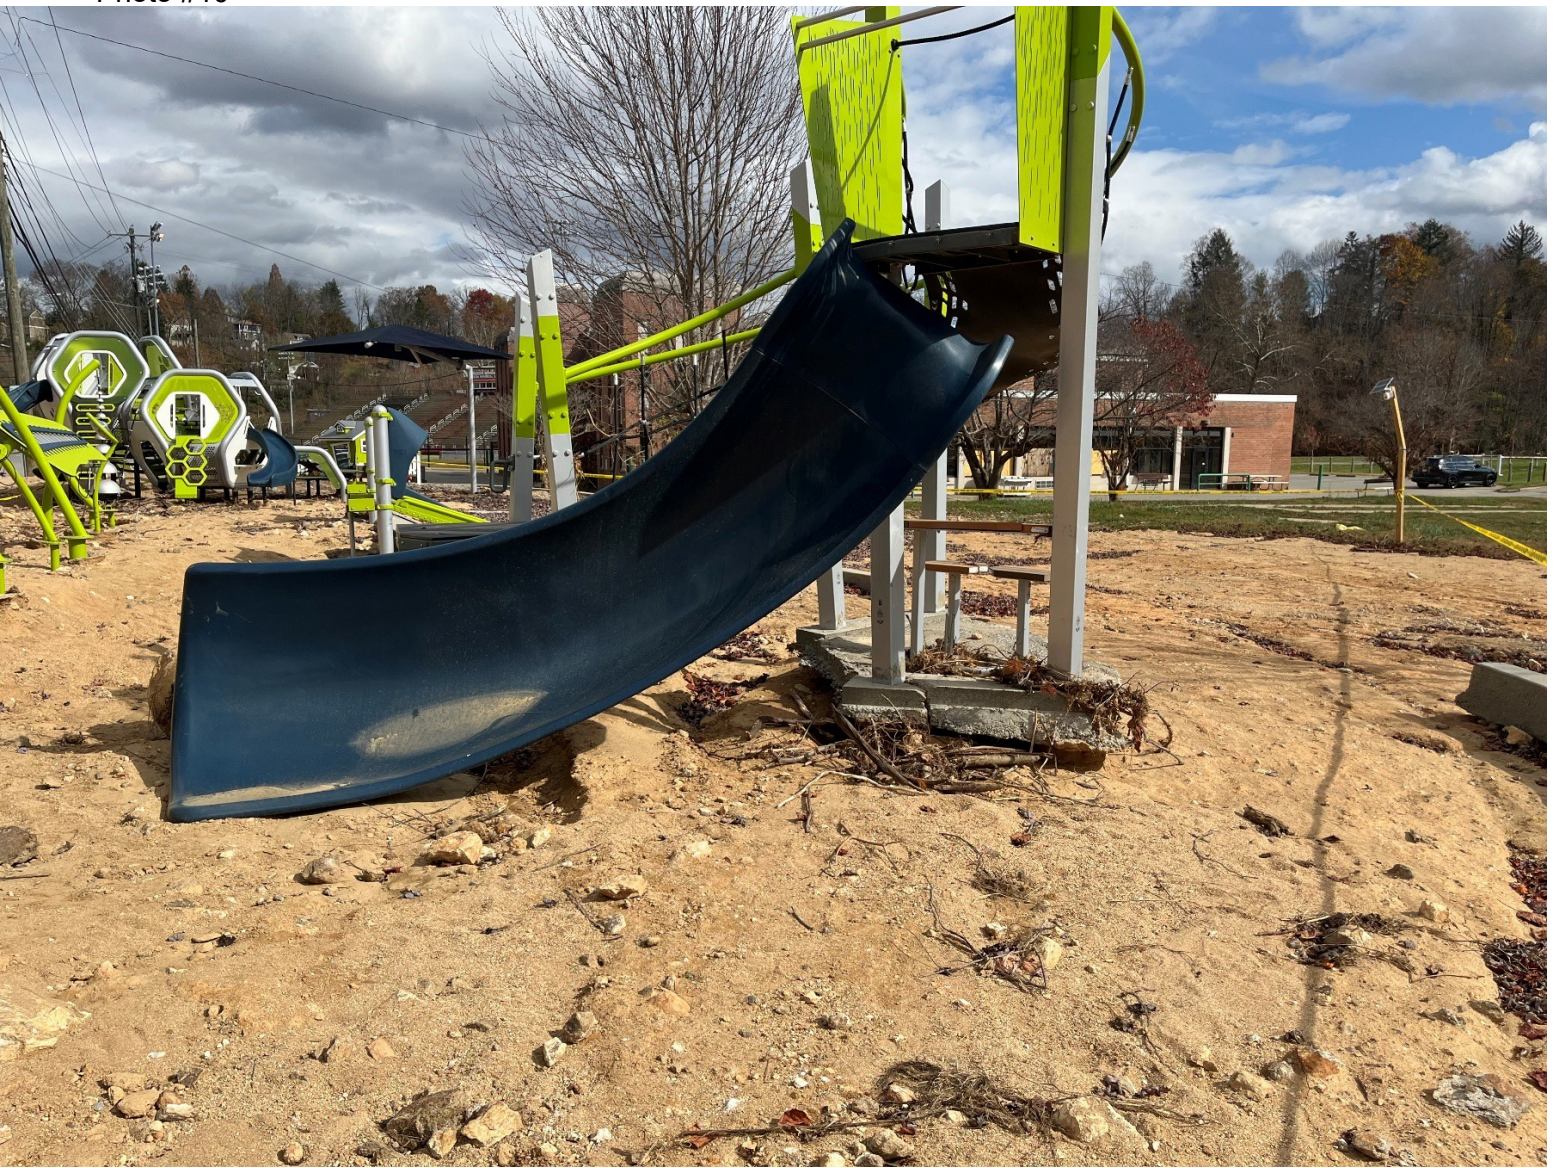
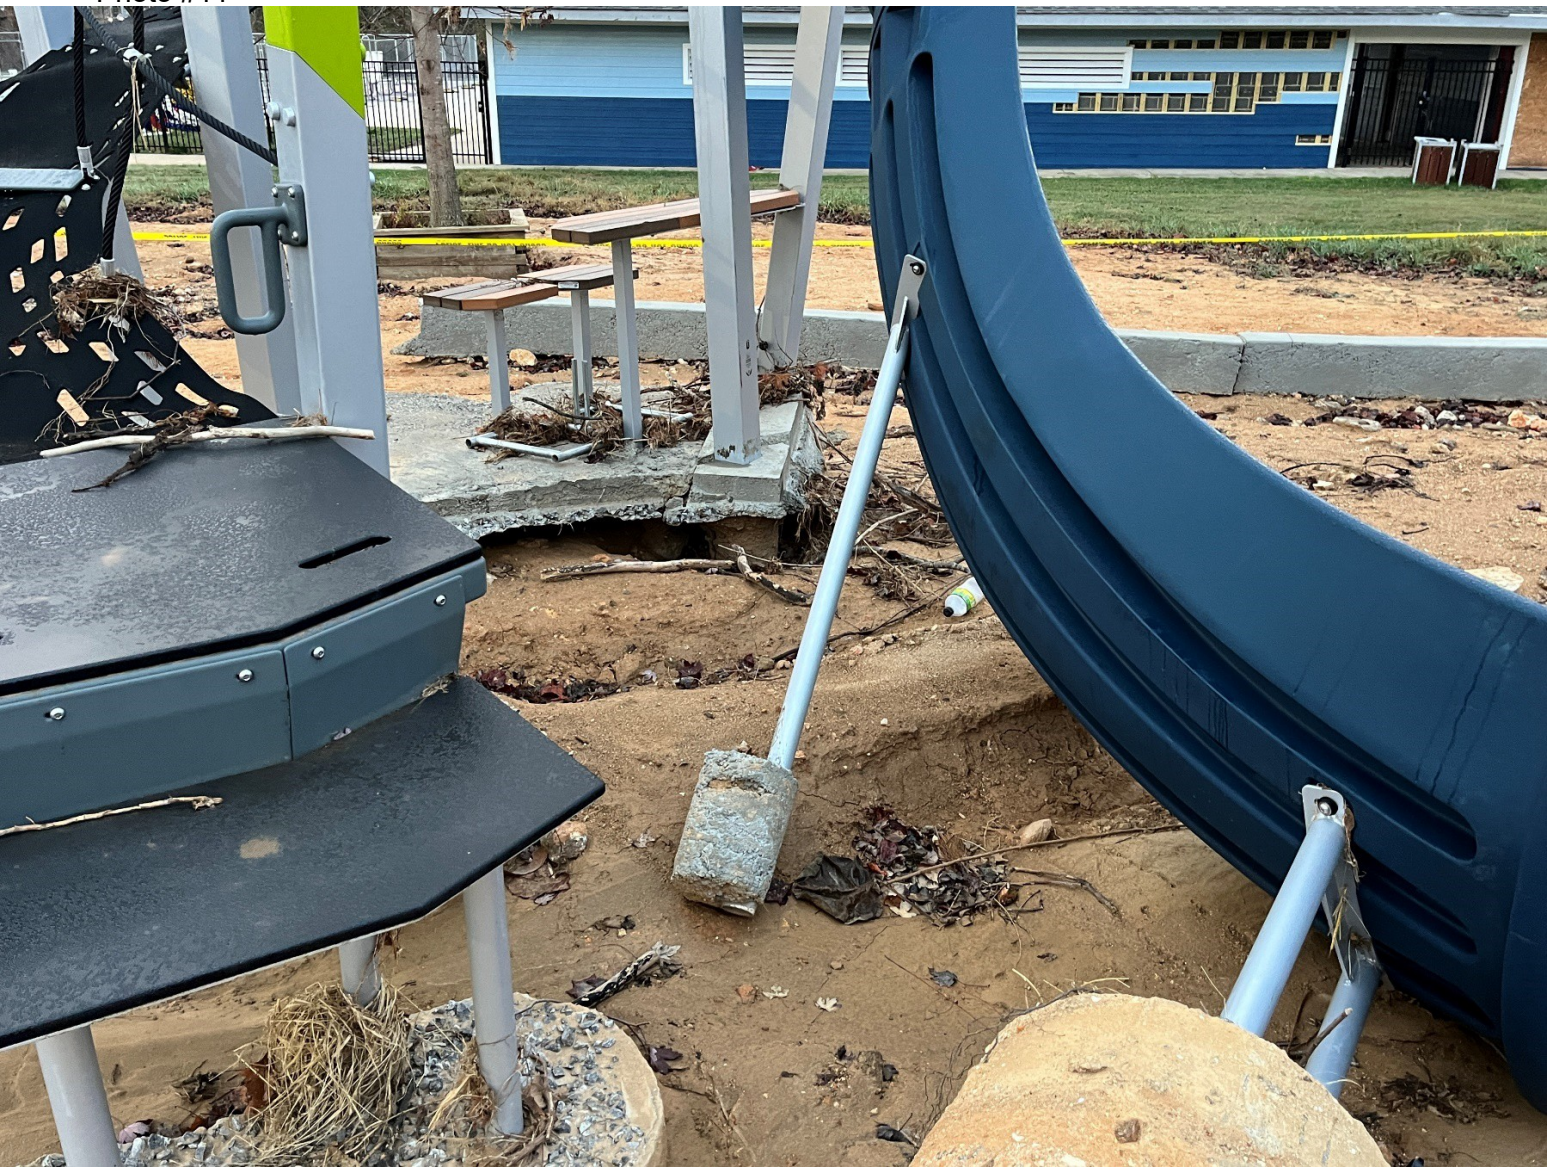
### **6. Alpine Slide (307427)- refer to photos #10 and #11**

- Compromised, posts missing, impacts from debris
- Foundations undermined and moved

- Demolish and replace
- Entire area needs regraded prior to placement of new footing and installation of new equipment

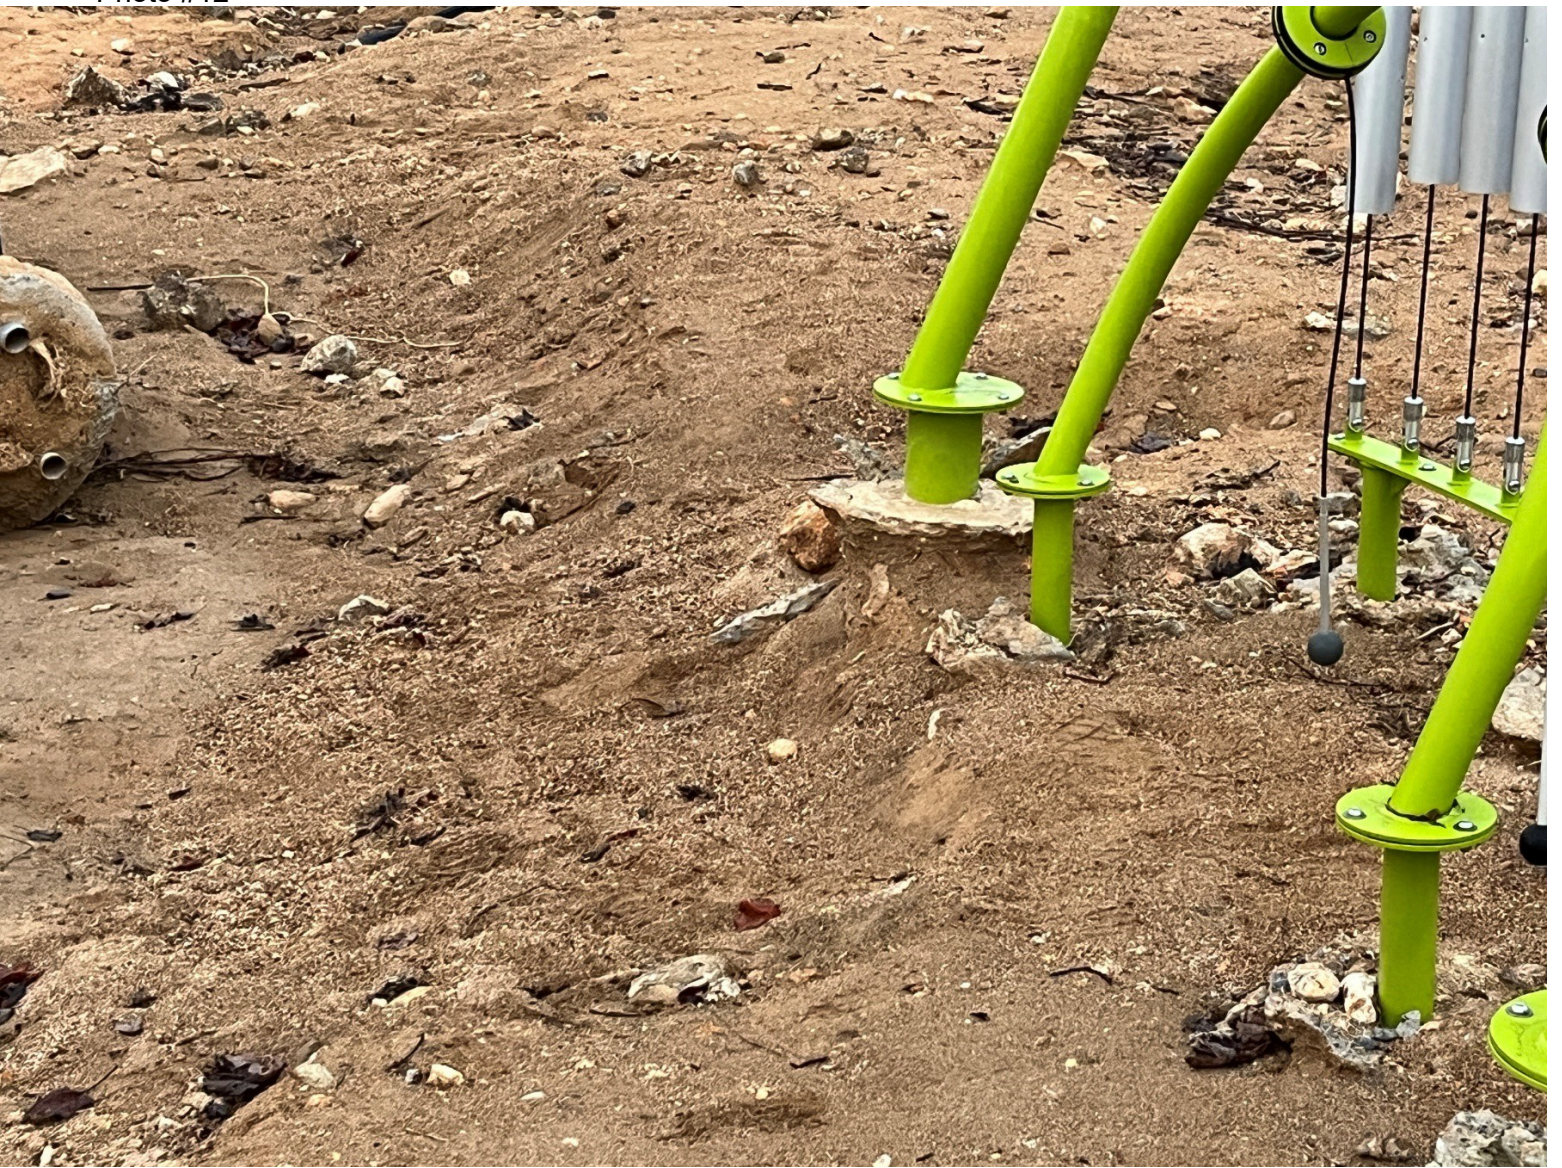
Photo #12

**7. Musical instruments (21442, 214438, 253114, 250346)- refer to photo #12**

- Remove, regrade, reset, touch up paint
- Entire area needs regraded prior to placement of new footing and installation of new equipment
- Disinfect equipment

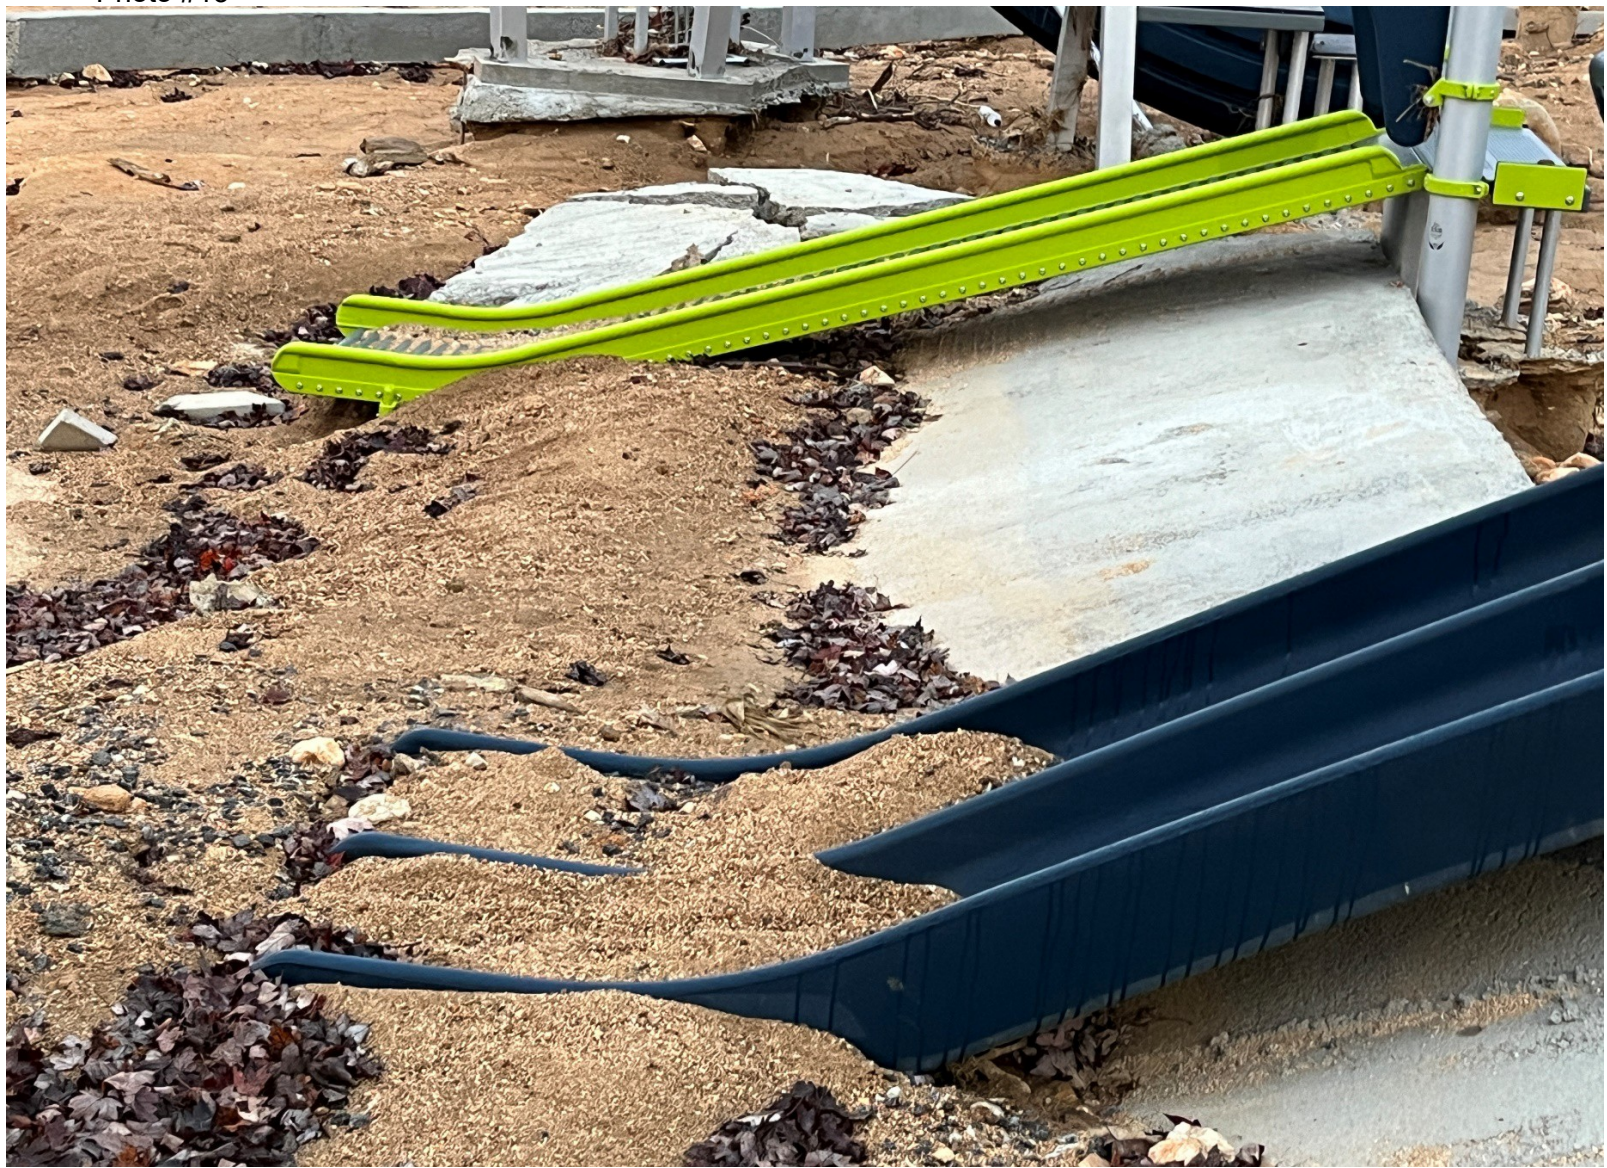
Photo #13

**8. Roller Slide (171589)-refer to photo #13**

- Demolish and Replace
- All concrete between roller slide and double slide should be demolished, area regraded, and replaced
- Entire area needs regraded prior to placement of new footing and installation of new equipment

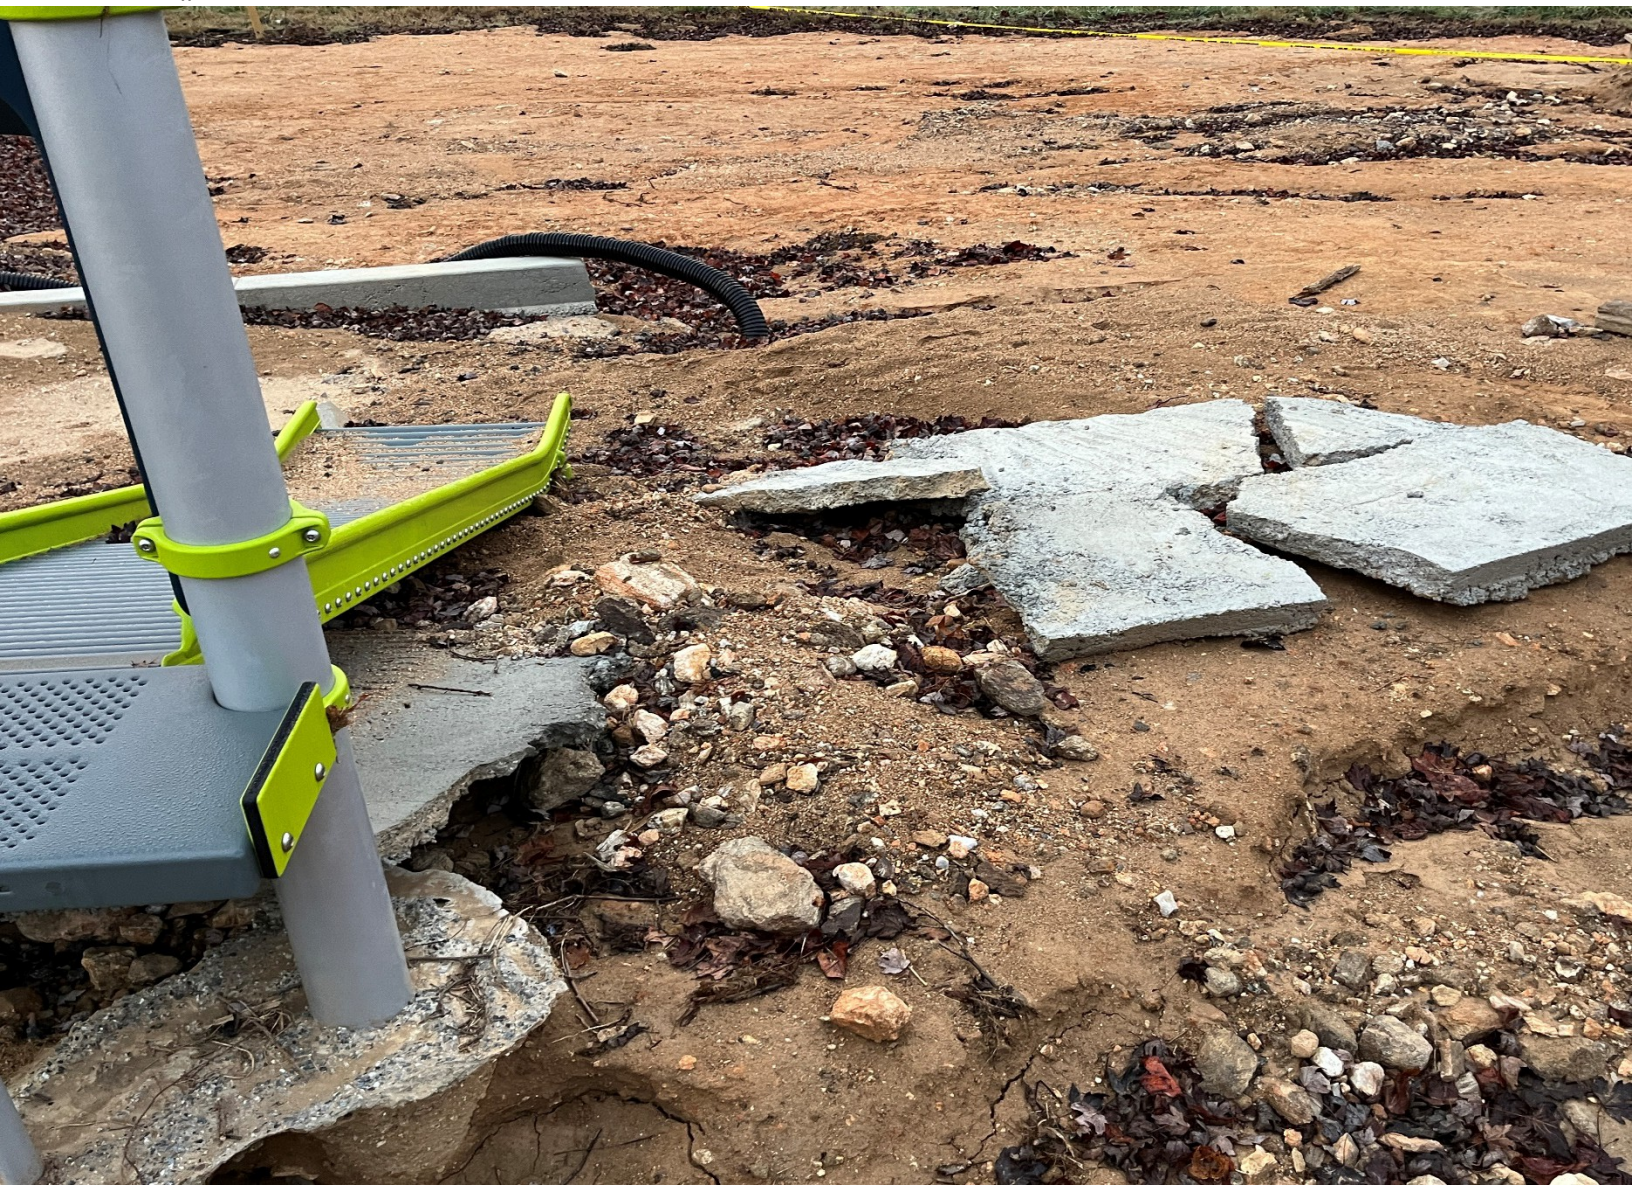
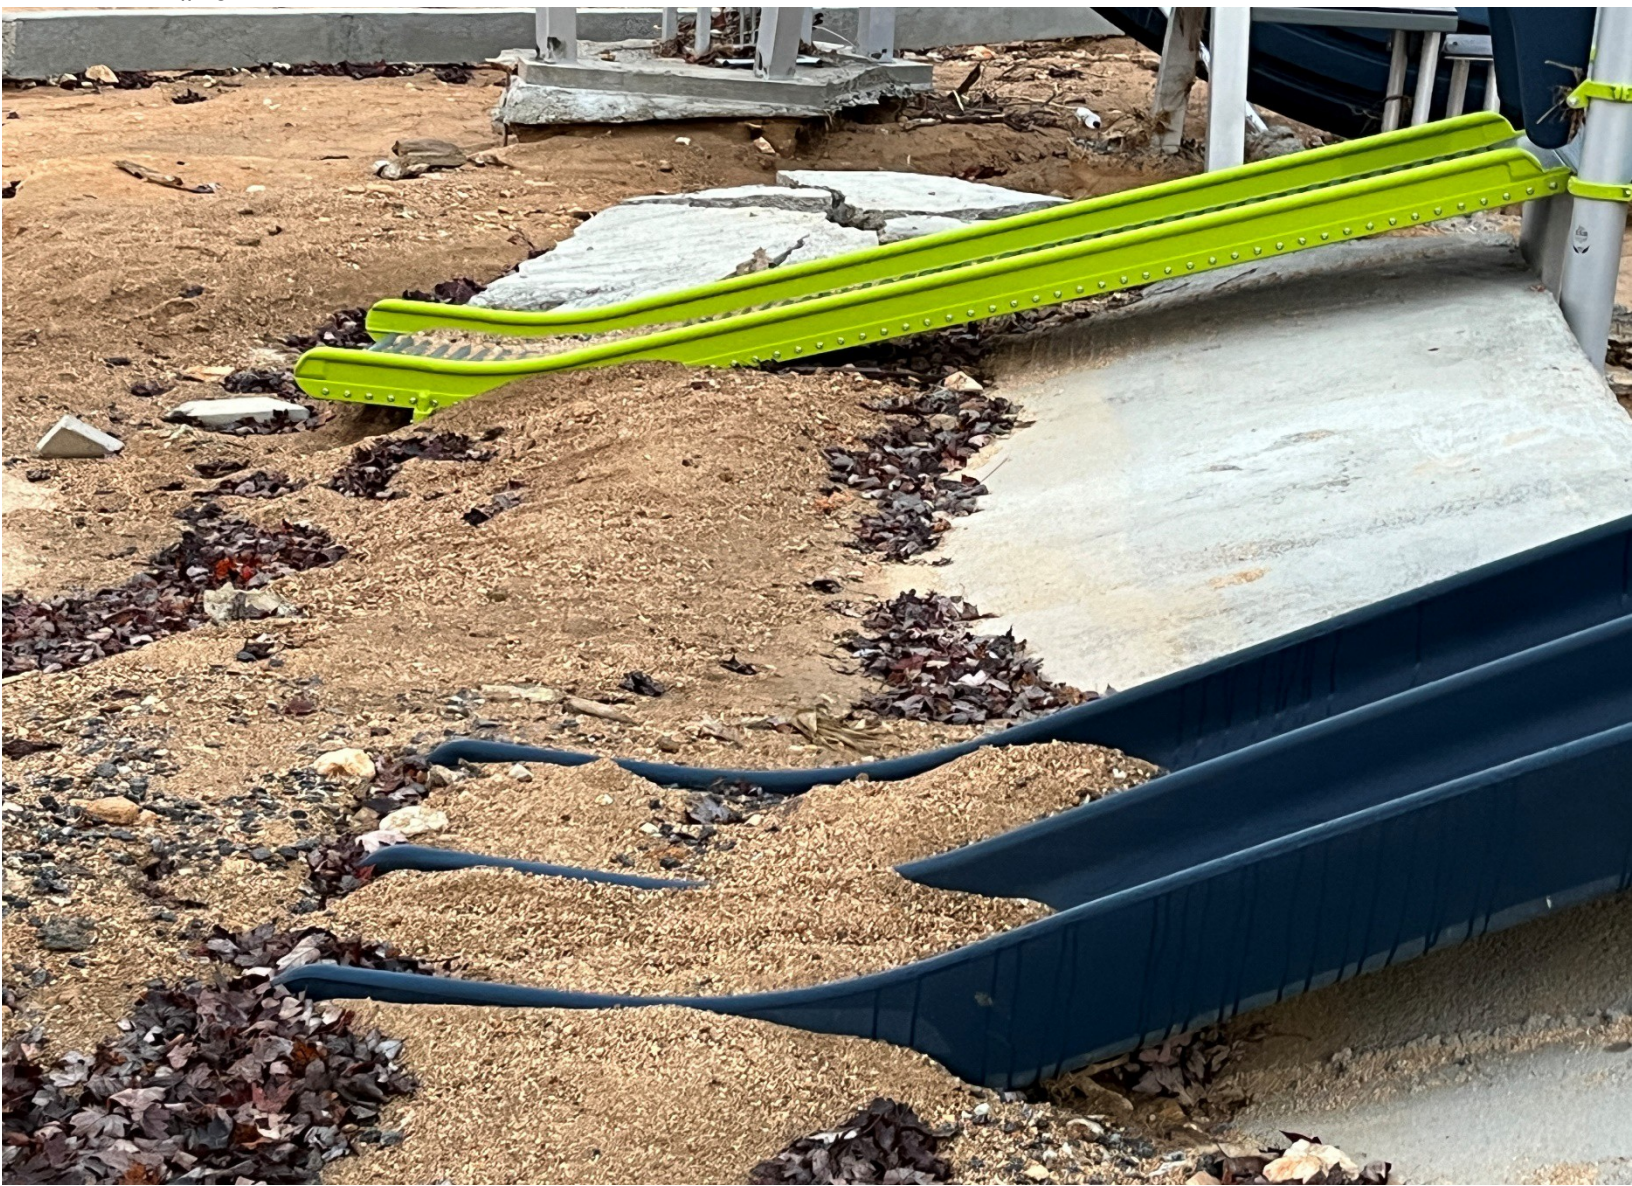
**9. Double slide (123331,171539) )-refer to photos #14 and #15**

- Significant damage, Demolish and replace
- Entire area needs regraded prior to placement of new footing and installation of new equipment

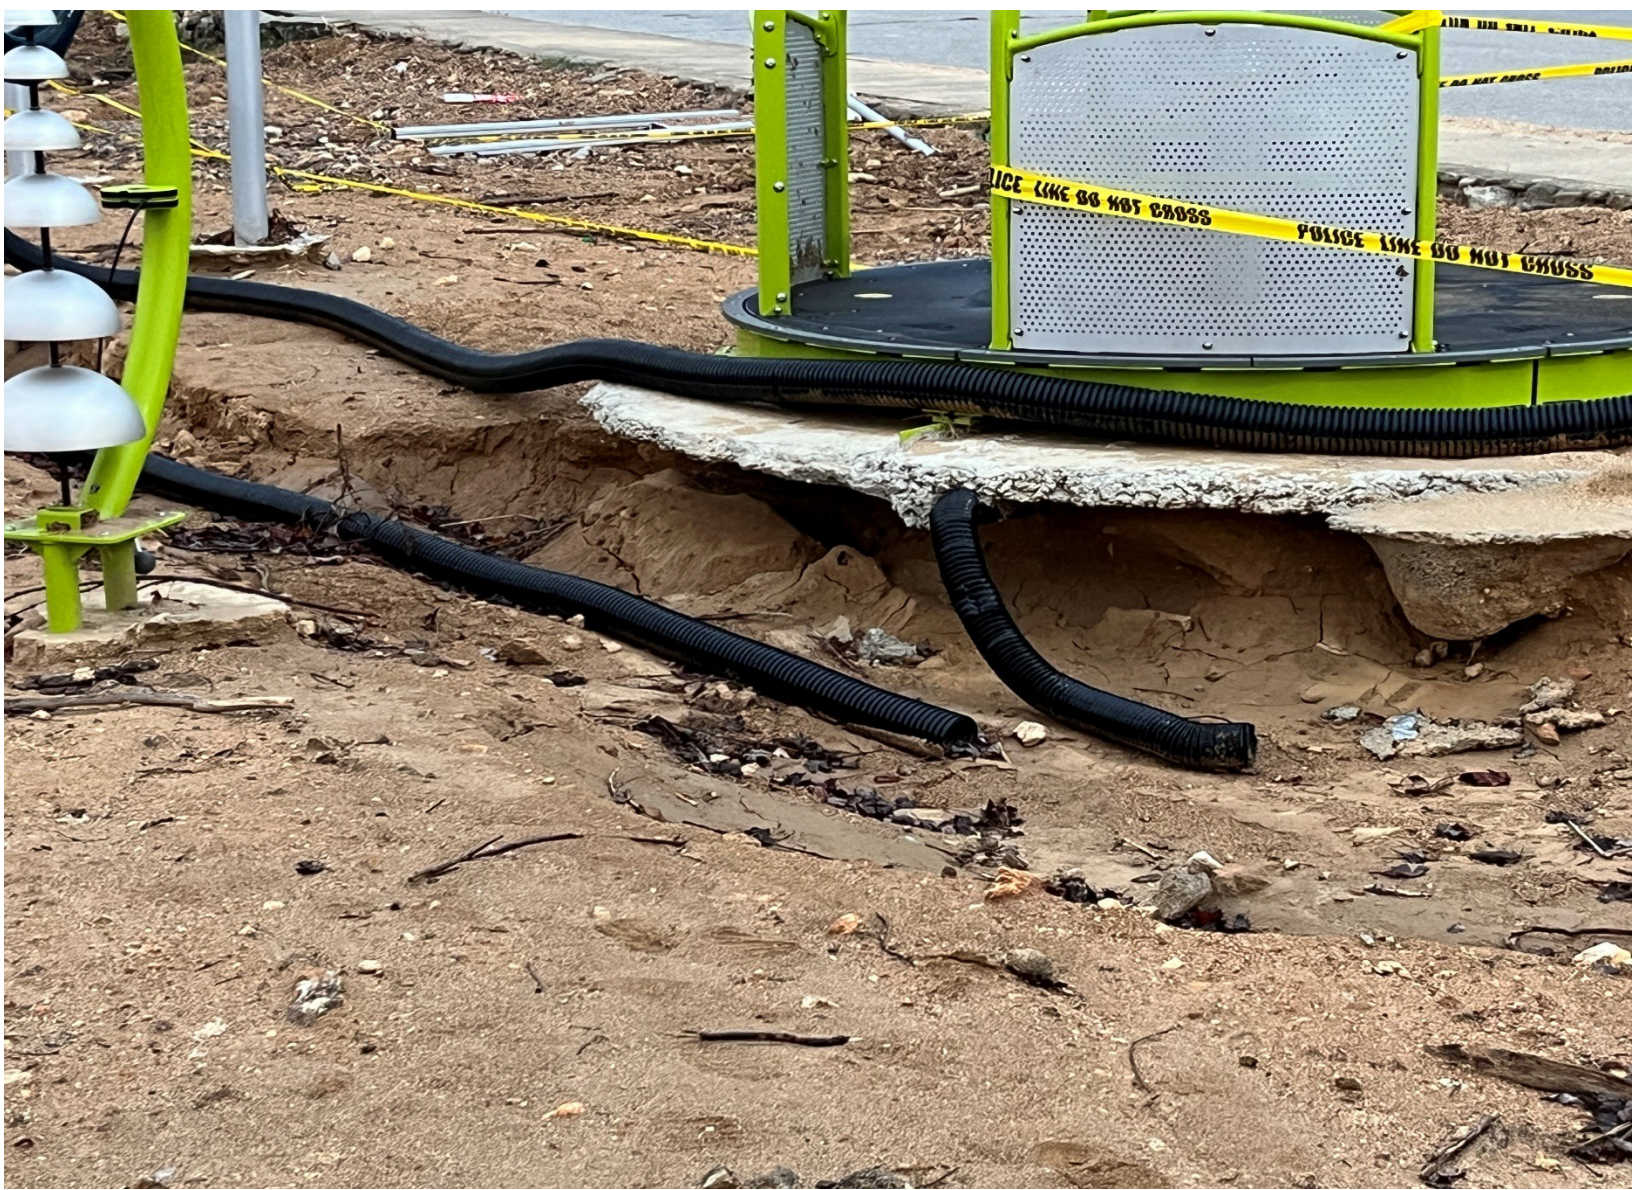
Photo #16

**10. We-Go-Round (248819) -refer to photo #16**

- Replace due to foundation, scour and mechanical parts being submerged
- Demolish and replace
- Entire area needs regraded prior to placement of new footing and installation of new equipment
- Concrete footing to be demolished and removed prior to regrading
