### **Rec Park – Playground**

## MEMORANDUM

**RE:** Canton Playground Repair Recommendations

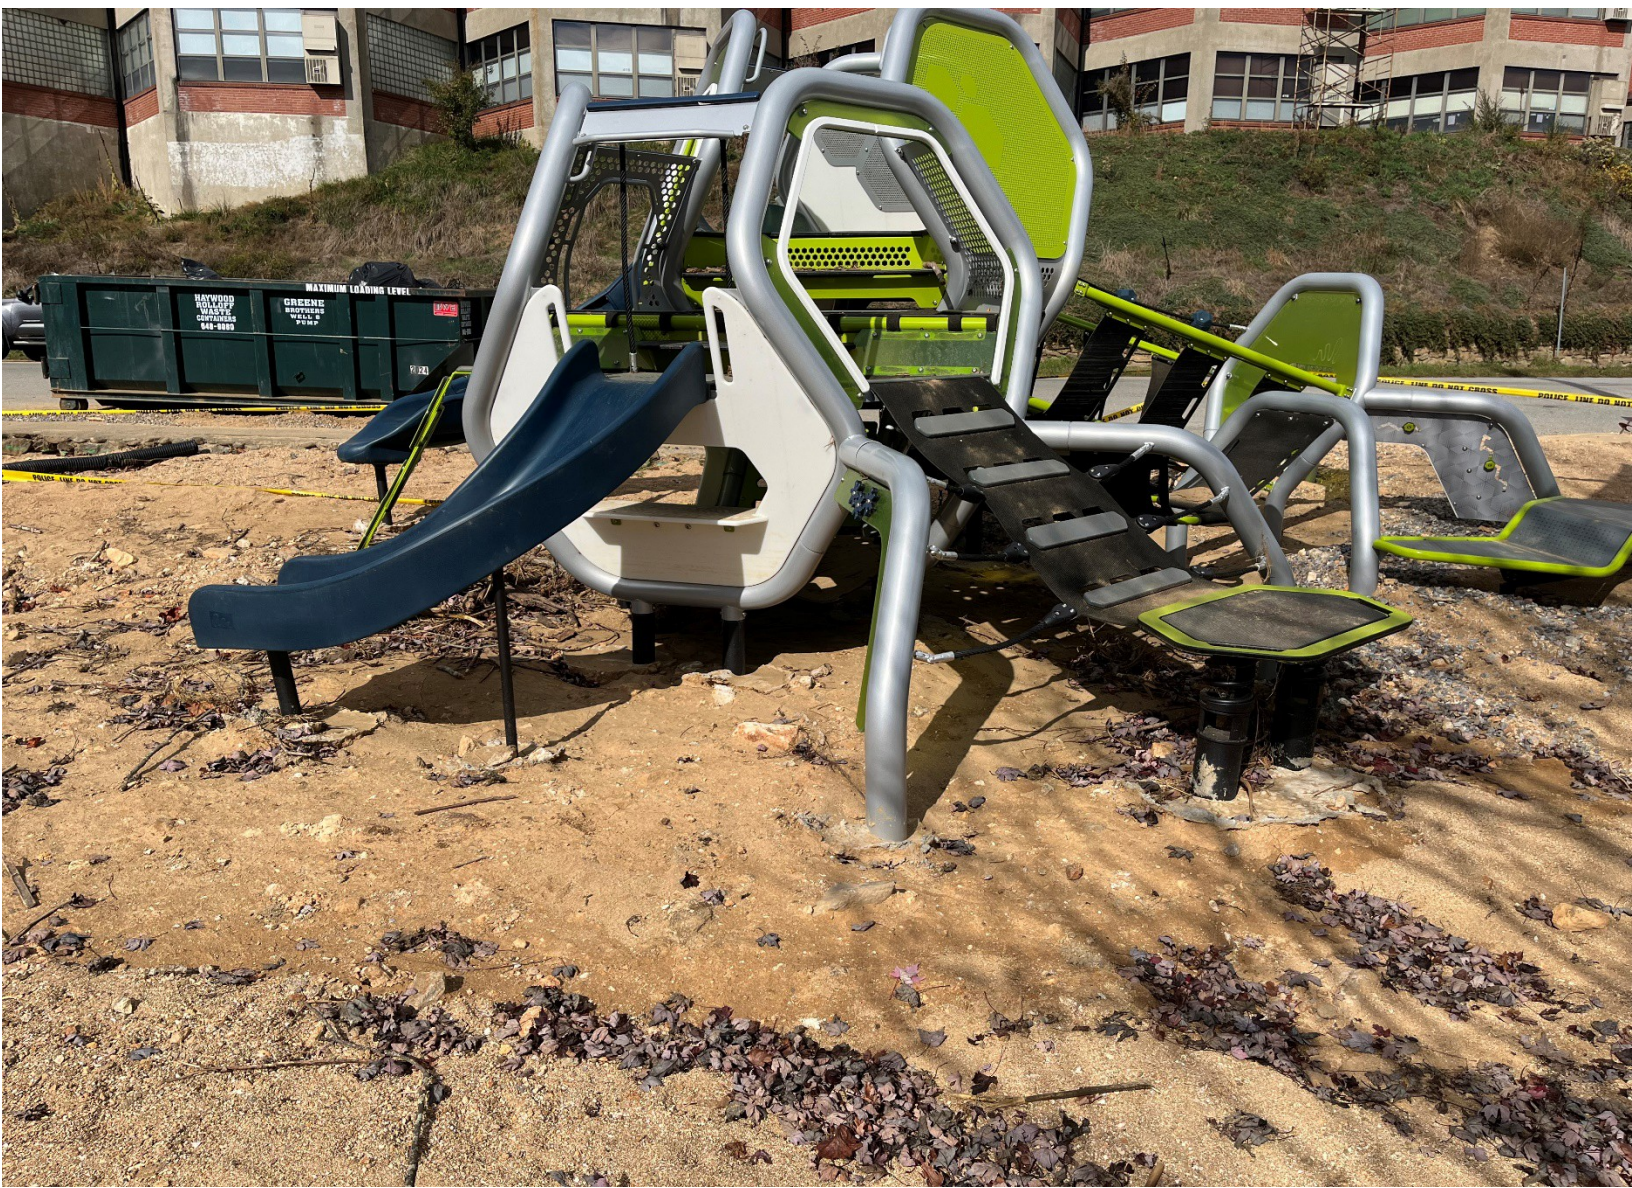
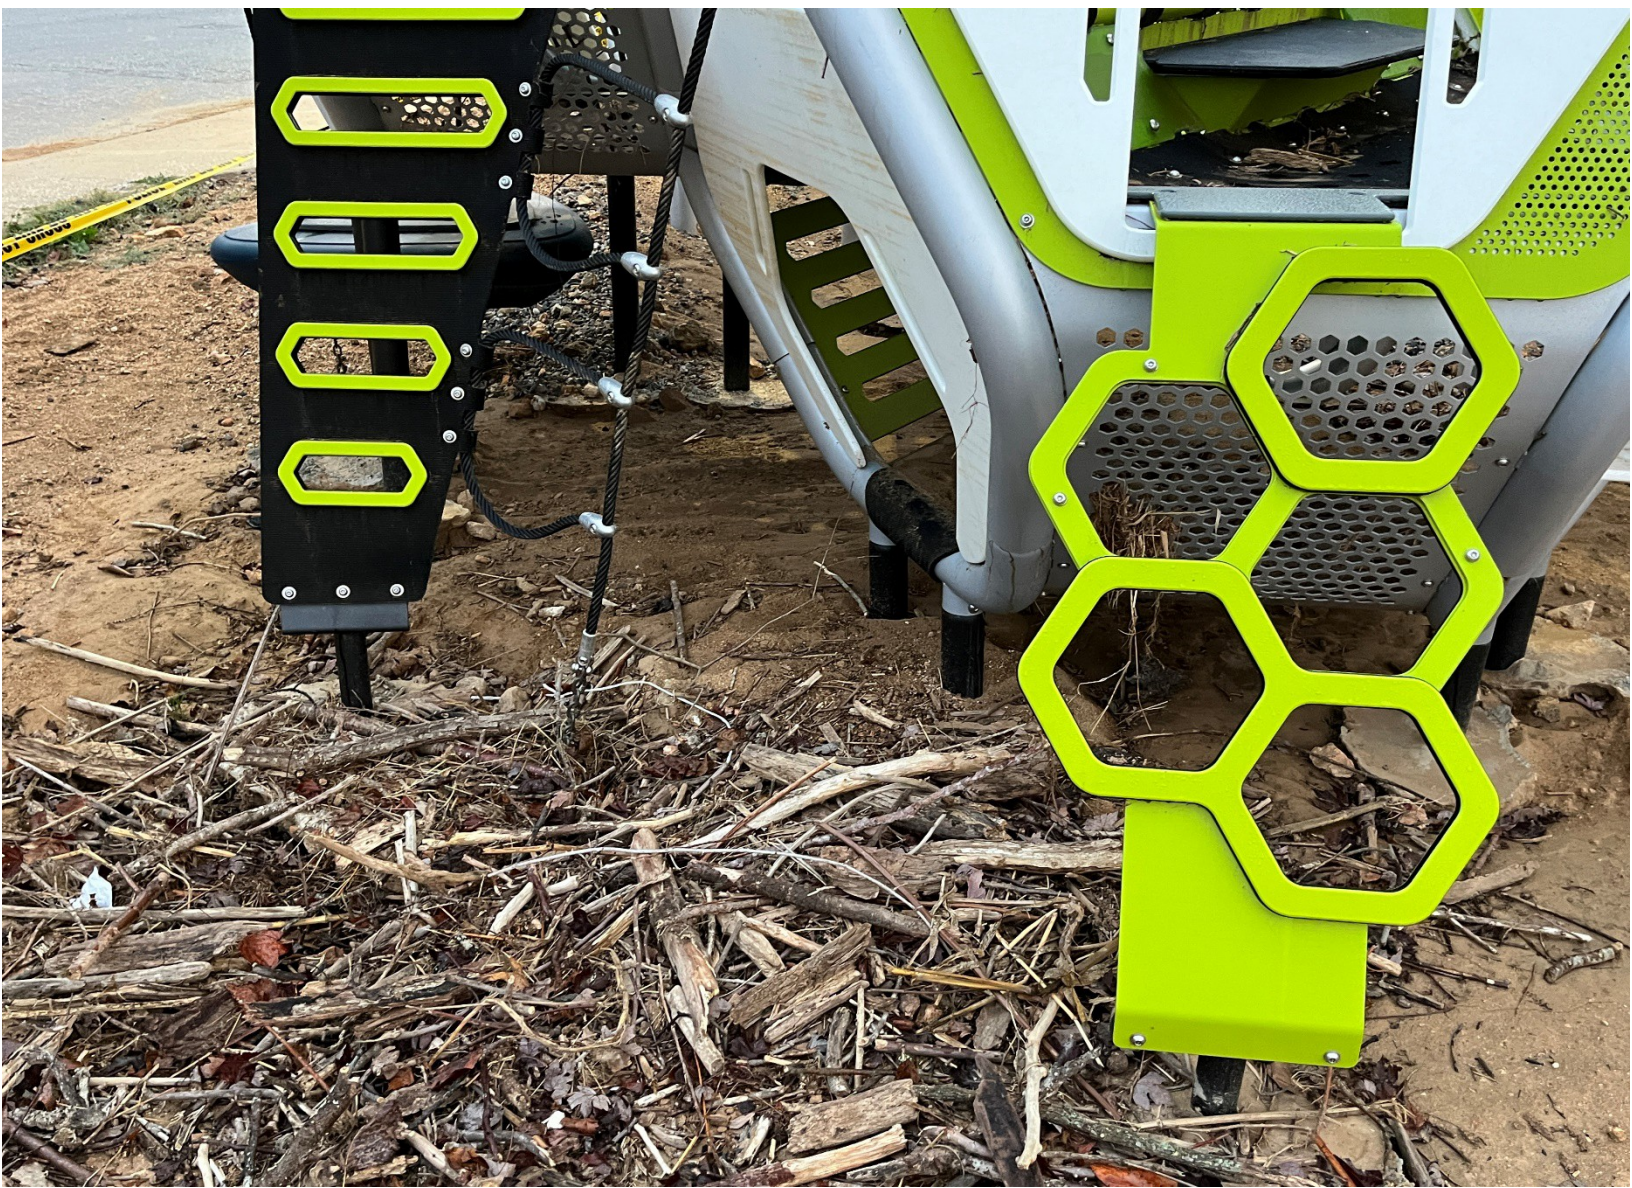
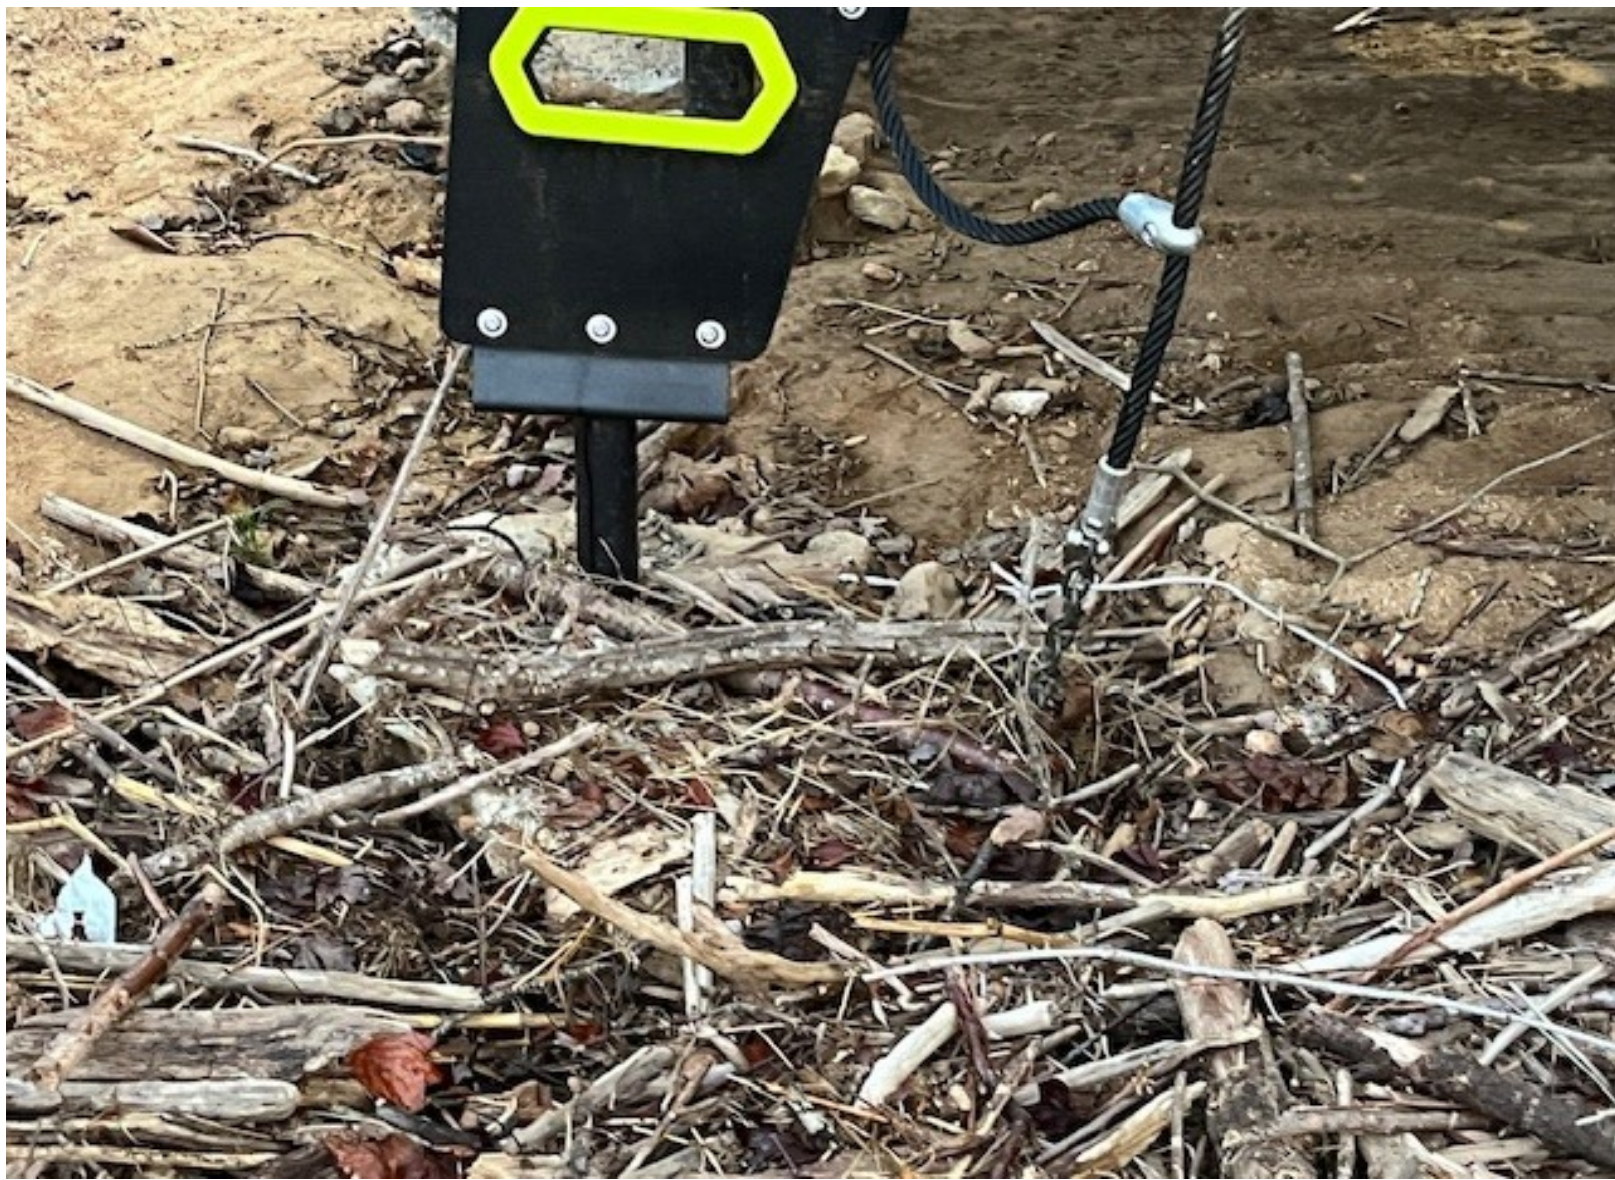
**11. Hedra Scout (265929)-refer to photos #17 thru #19**

- All footings scoured and filled with loose sand
- Demolish and replace
- Entire area needs regraded prior to placement of new footing and installation of new equipment

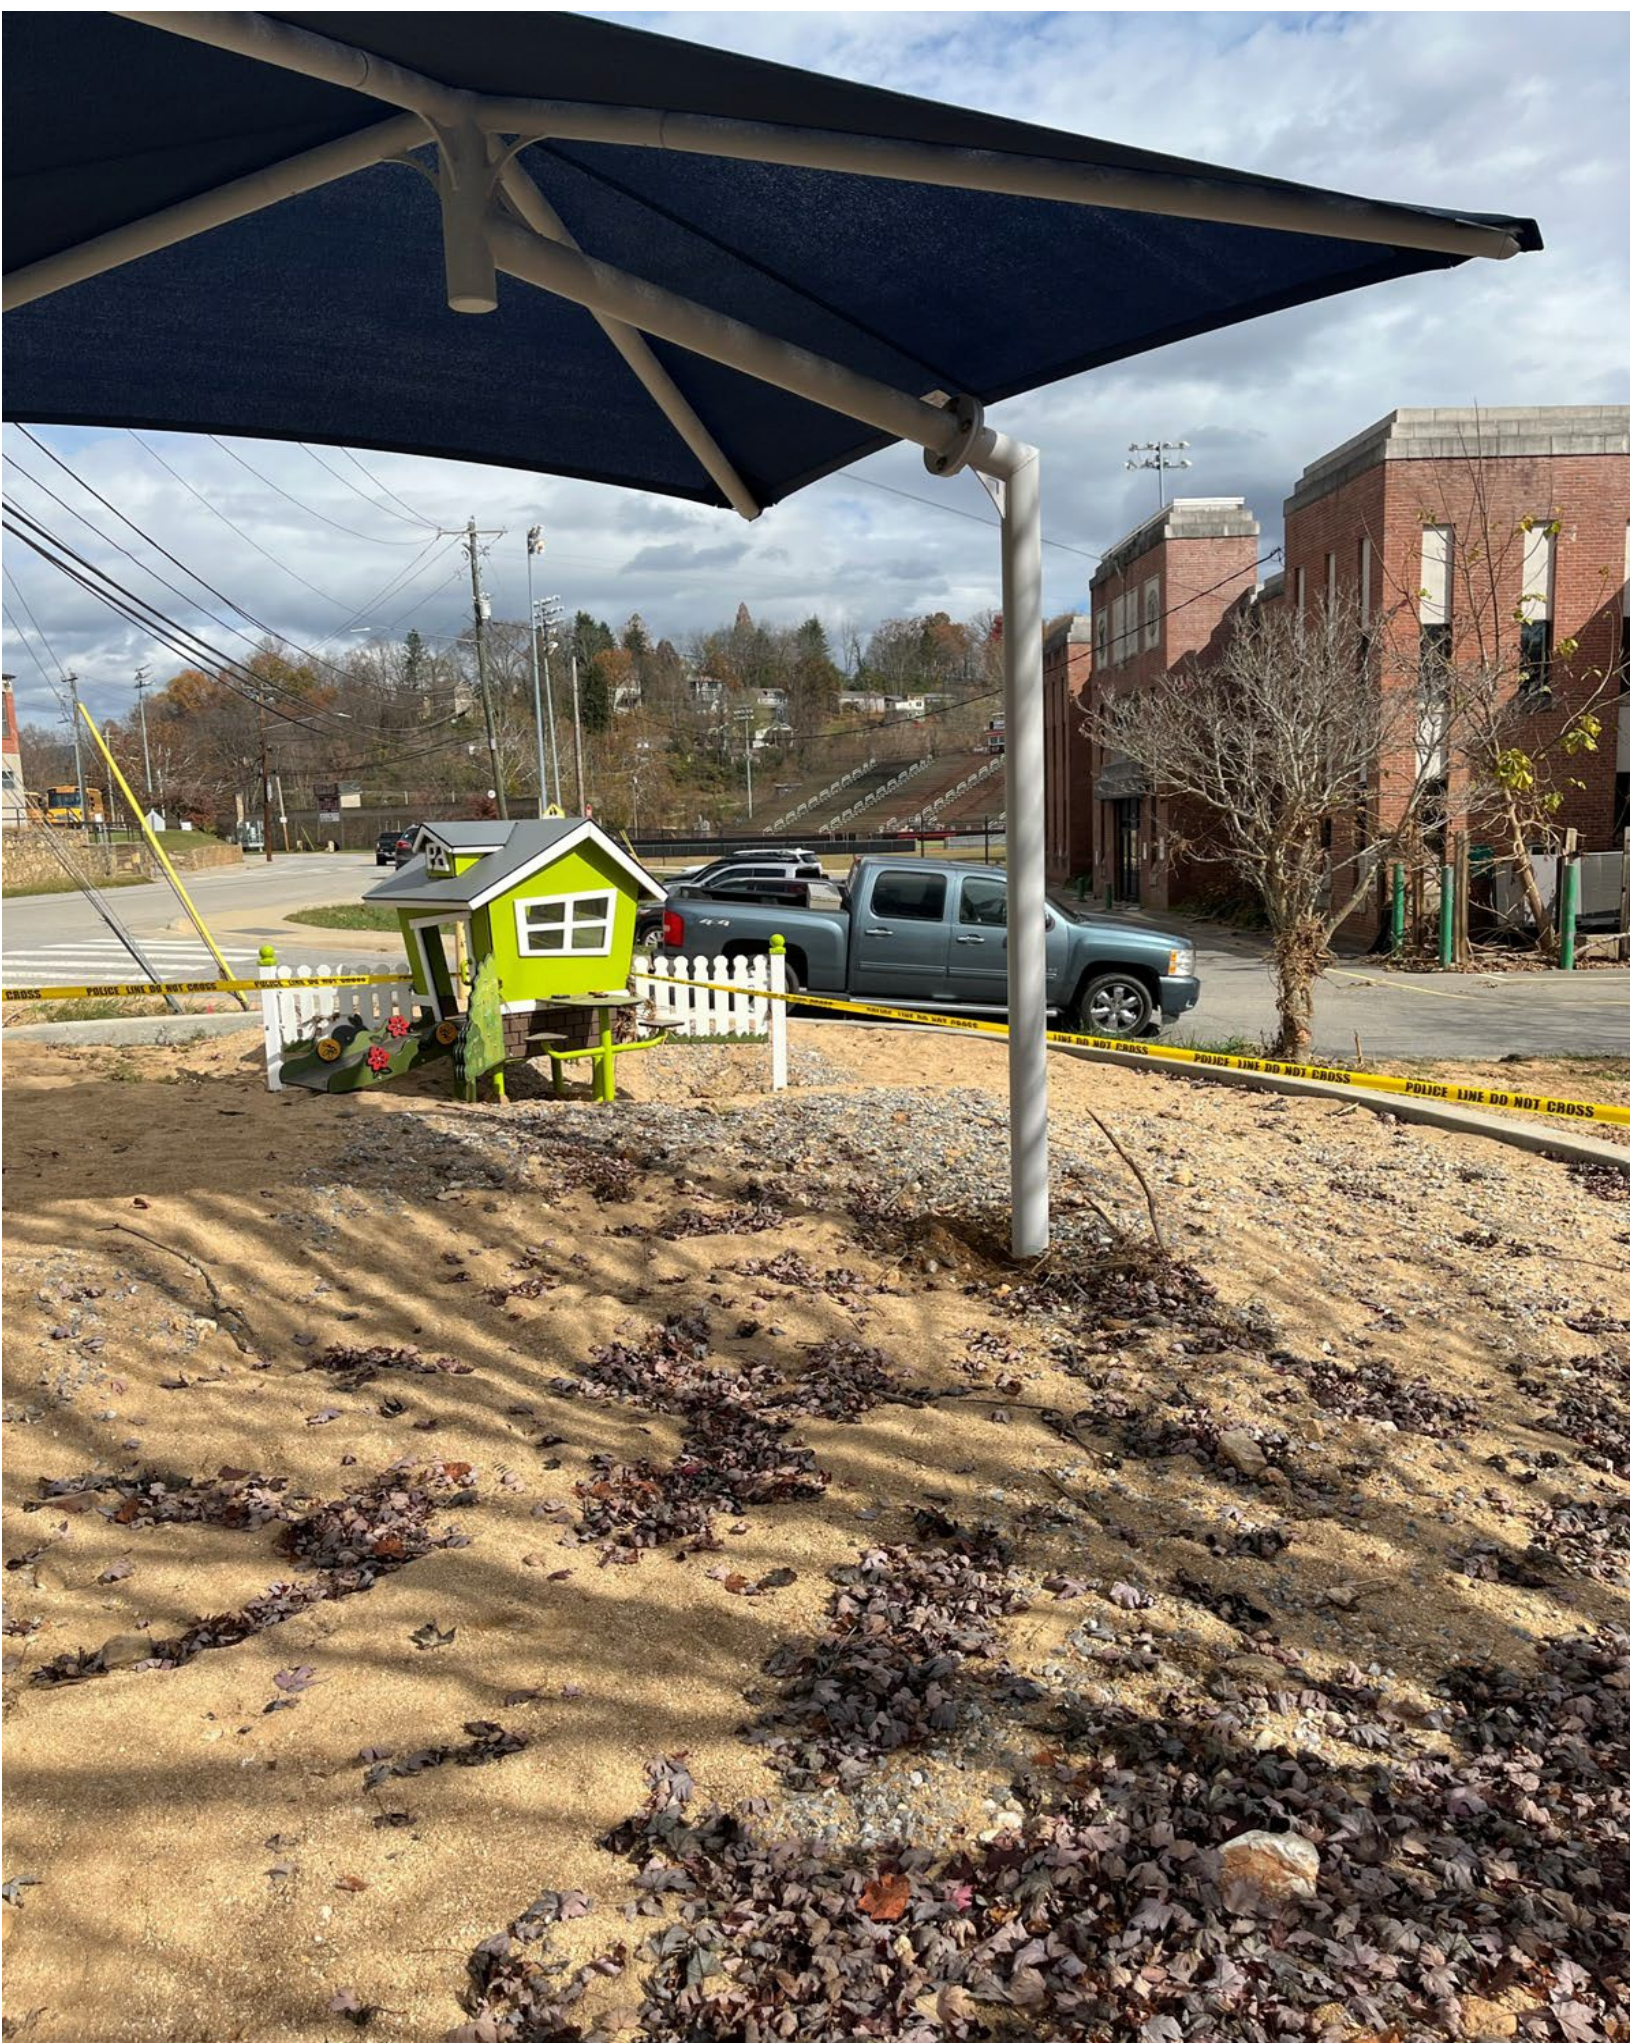
**12. North Shelter (237673)-refer to photo #20**

- Unbolt, store, regrade area, replace original footing and anchor bolts per specification
- This equipment will be removed and reinstalled, no damage to shelter or shelter base
- Disinfect equipment

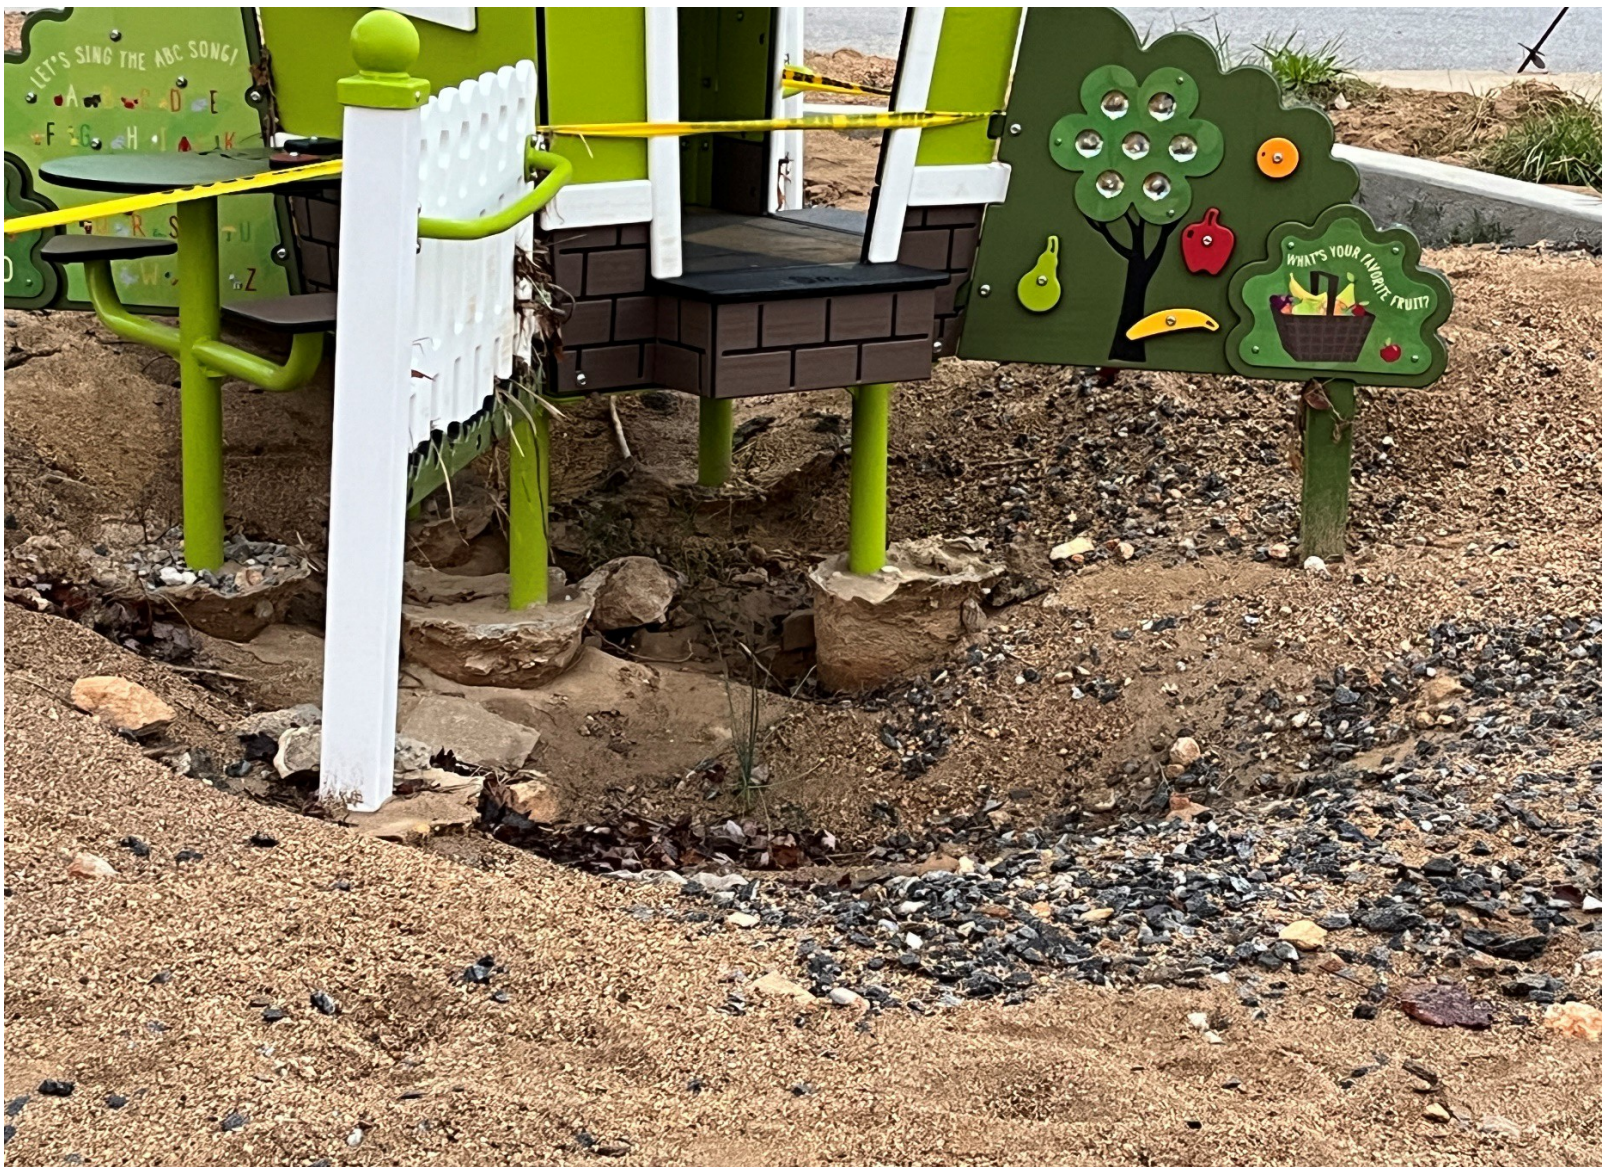
Photo #21

**13. Nook (223856)-refer to photo #21**

- All footings scoured and filled with loose sand
- Demolish and replace
- Entire area needs regraded prior to placement of new footing and installation of new equipment

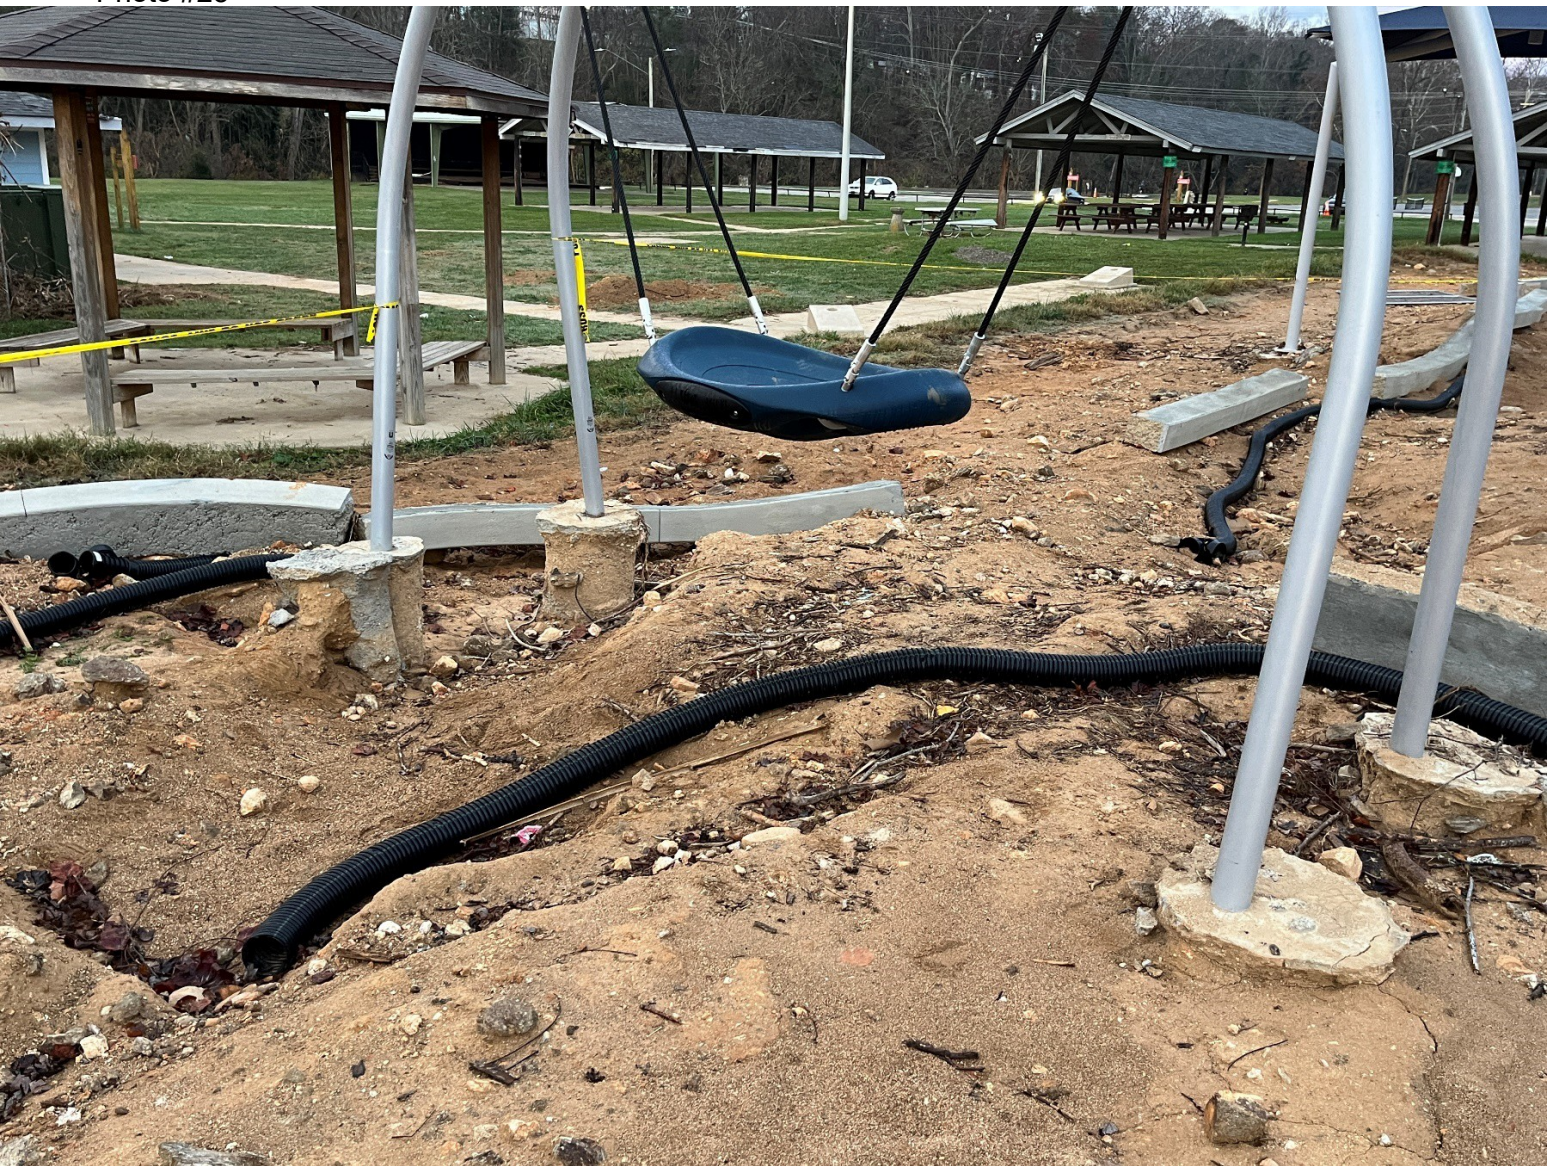
Photo #25

• **Concrete Curbing-refer to photos #25**

- All curbing damaged beyond repair

- Demolish and replace all curbing per original design
- **French Drain-refer to photos #25**
  - Completely destroyed during storm event
  - Demolish and replace per original design
- **Welcome and Talking is Teaching Sign)-refer to photo #26**
  - These signs Need to be replaced and installed per original plan
