Canton Town Hall Reno
Project No.: 2023-001-02
Issue to: Bidders

Town of Canton, Owner
Contract Document Date: July 07, 2025
Addendum Date: March 31, 2026

CANTON, NC MUNICIPAL PROJECT - ENVIRONMENTAL SERVICES

ECS Southeast, LLP (ECS) is pleased to provide Creech & Associates with the results of the Environmental Services performed at the above referenced property. This report summarizes our observations, analytical results, findings, and recommendations related to the work performed. The work described in this report was performed by ECS in general accordance with the Scope of Services described in ECS Proposal Number 49:37253P and the terms and conditions of the agreement authorizing those services.

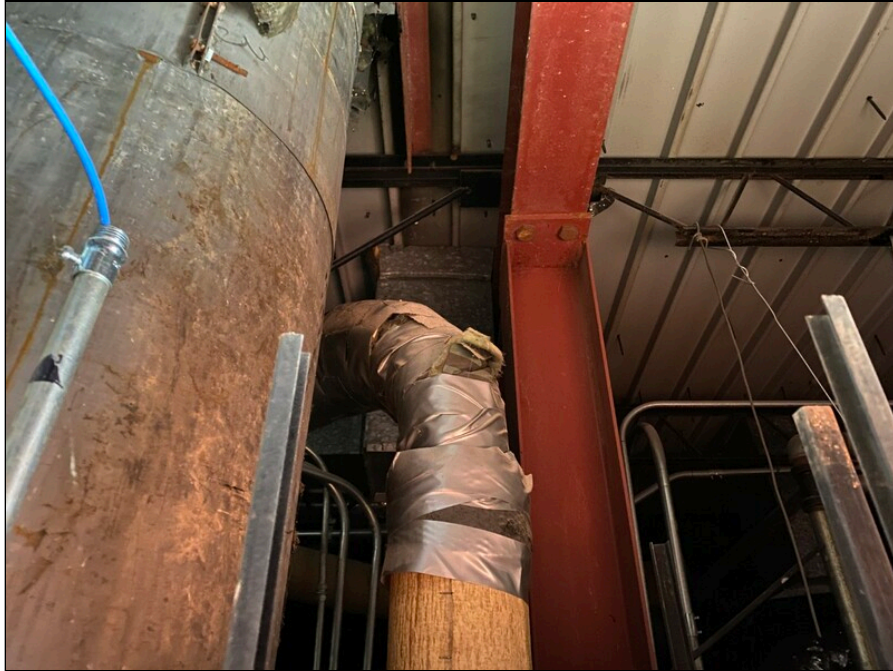
7 - View of fiberglass piping.

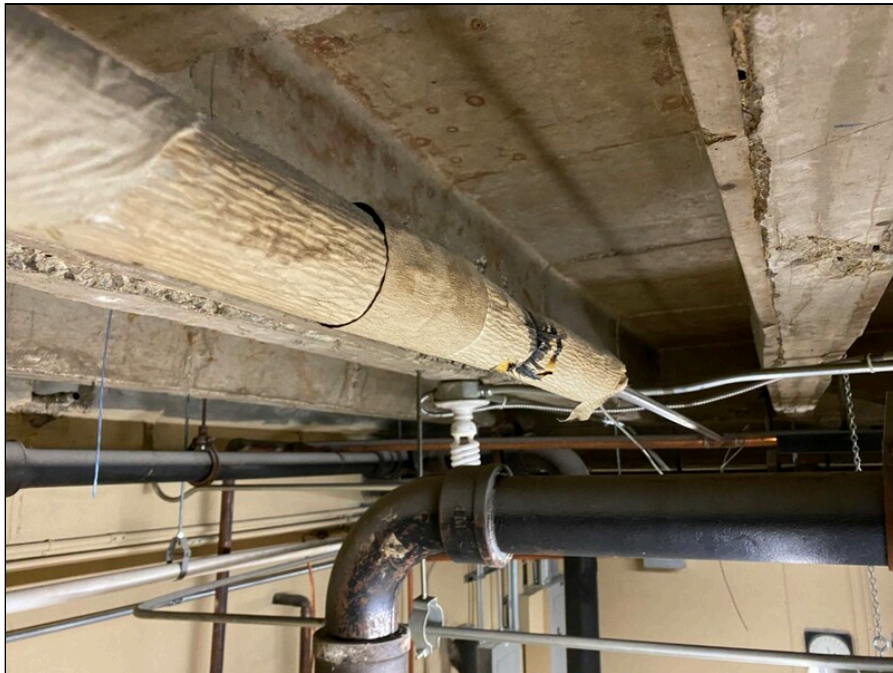
8 - View of fiberglass piping, with ACM white mudded fittings.

ECS recommends that ACMs are abated prior to demolition activities that may disturb them. ECS recommends where a material type has been identified as asbestos-containing that other materials with similar color, texture, age and size throughout the building's interior and exterior be assumed to contain asbestos. Please refer to Section 4.1 for a complete list of building materials that were reported positive for asbestos and to Section 4.2 for materials that were assumed to contain asbestos. ACMs should be removed prior to disturbance.

If ACMs are to be removed, it is recommended that an industrial hygienist monitor the project. This involves collecting air samples from within and outside abatement work areas to monitor the asbestos abatement contractor's work practices over the course of the project. The industrial hygienist should evaluate if the asbestos abatement work is in accordance with project specifications, U.S. EPA regulation 40 CFR Part 61-National Emission Standards for Hazardous Air Pollutants Subpart M: National Emission Standard for Asbestos, and U.S. Occupational Safety and Health Administration (OSHA) regulation 29 CFR 1926.1101 - Asbestos in Construction. The industrial hygienist should assess each work area to monitor the removal of ACMs. Only after the industrial hygienist has determined the identified ACMs have been removed should final clearance air samples be collected (if necessary).

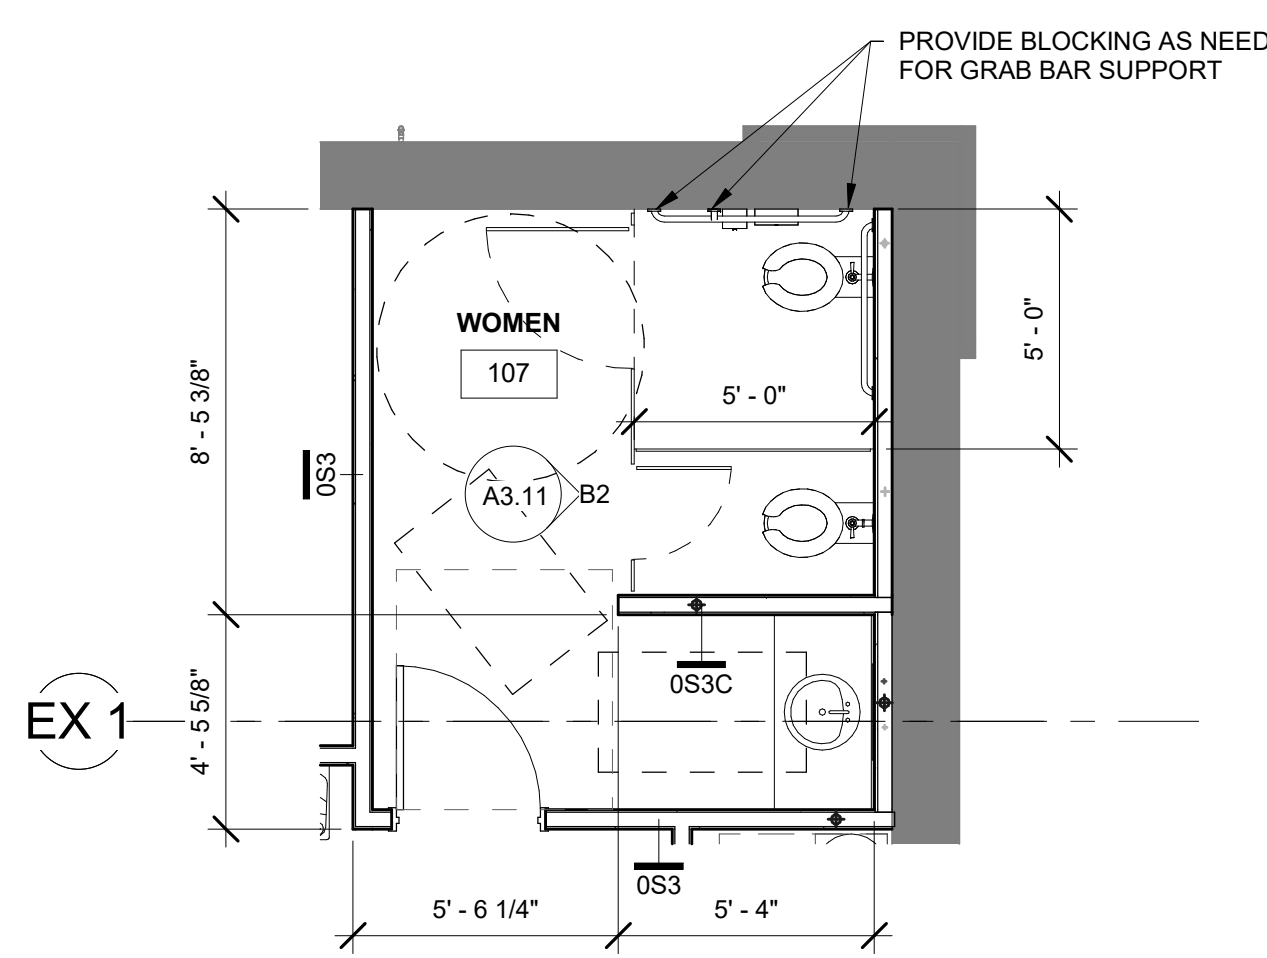
B1 ENLARGED WOMEN 107
1/4" = 1'-0"

- c) Please confirm base in rooms 107 and 109. Schluter Dilex is the base for this room, however, this product is not a Please clarify the base in rooms 107 and 109. The TS-1 Schluter Dilex is the only "Base" called out for this room. However, this material is only applicable in wall tile/Floor tile transitions.
 - 1) See revised Drawings.
